# Safety Assessment: Experimental Testing – Commercial Pipework Leakage

Comparison of hydrogen and methane leak rates on a commercial gas pipework system, specifically the gas meter and equipment contained within the Plant Room of a MOD site.

**Project 204**  
**Hy4Heat WP7 – Lot 1 Variation**  
**Plant room testing**

**Final Report**

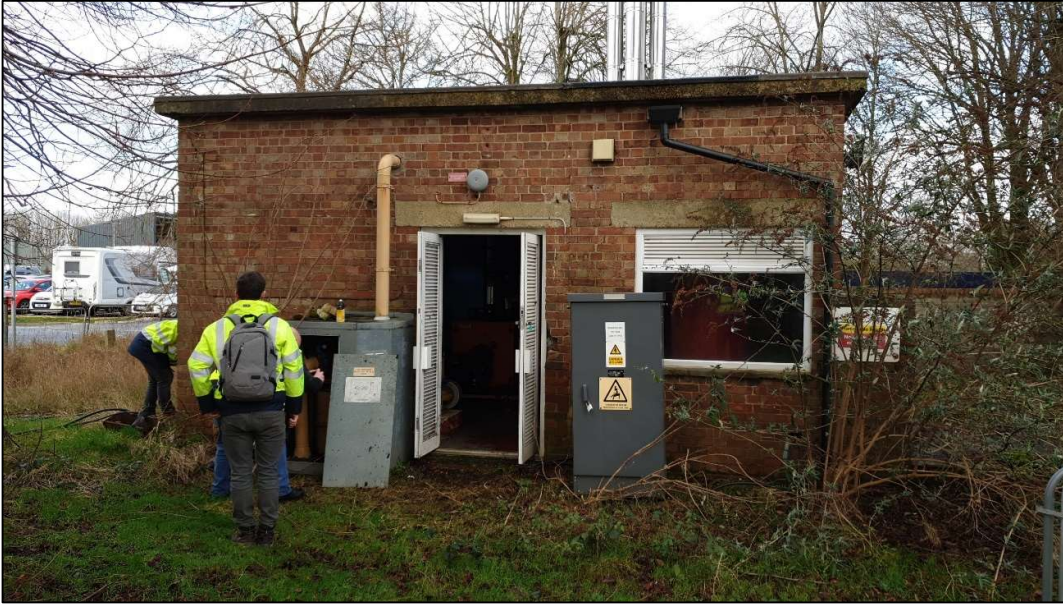
*Figure 2: Looking north towards the plant room, building 41*

Key features outside of the building were the location of the meter cabinet, the incoming gas supply and the vented windows and doors to prevent build-up of gas in the building.

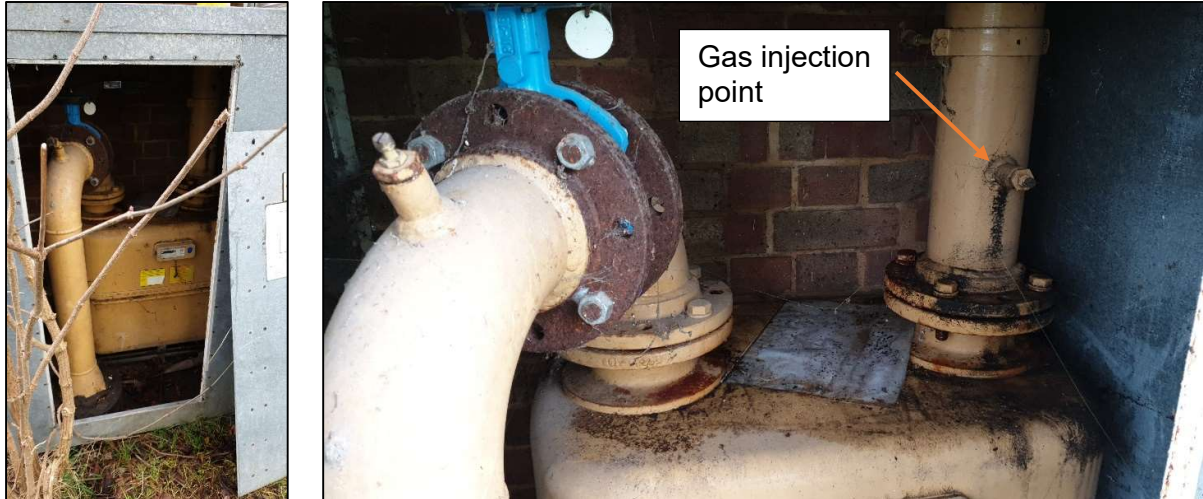
Figure 4: Meter cabinet with blue ECV and test point used for gas injection

The test point shown on the right of Figure 4 was used as the gas injection point for all of the tests. The blue butterfly valve to the left was the manual isolation ECV (emergency control valve) for the meter and the plant room.

The purge gas was connected into the system via the injection point, shown in Figure 4. All valves were opened and the plugs in the purge lines were removed. Three exhaust lines were connected from the purge points to a purging stack, shown in Figure 15. The stack was then placed downwind and away from the working space. Finally, a gas meter was used to record the volume of gas passing through the stack.

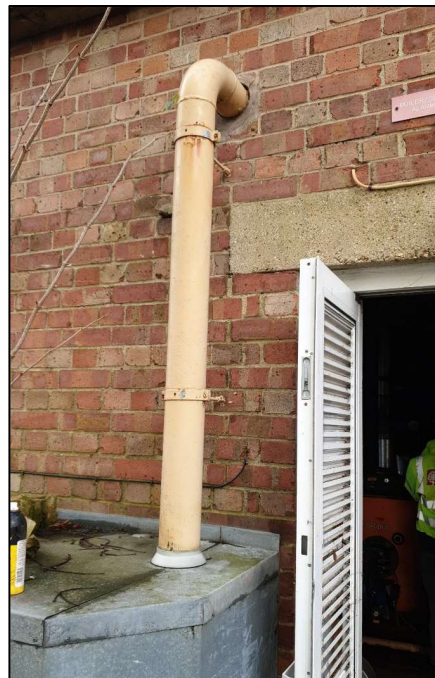
Figure 5: Four-inch pipe from meter cabinet into the plant room

The supply line to the building from the meter was a four-inch nominal bore steel gas line, shown in Figure 5.

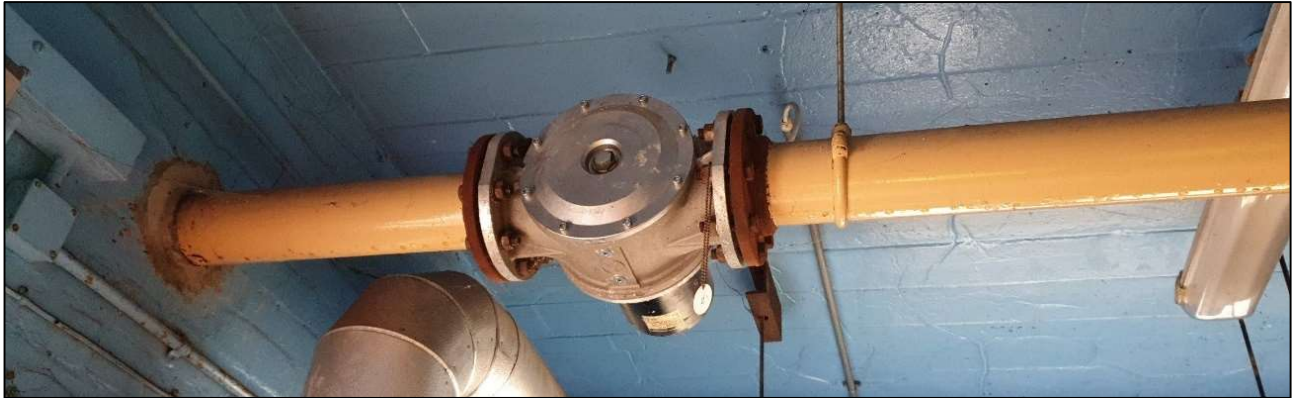
*Figure 6: Electrically operated solenoid valve (SOV)*

The four-inch pipe passed through the south wall of the plant room and connected to a 230 VAC electrically operated solenoid valve (SOV), shown in Figure 6. It then extended into the building above the boilers as shown in Figure 7.

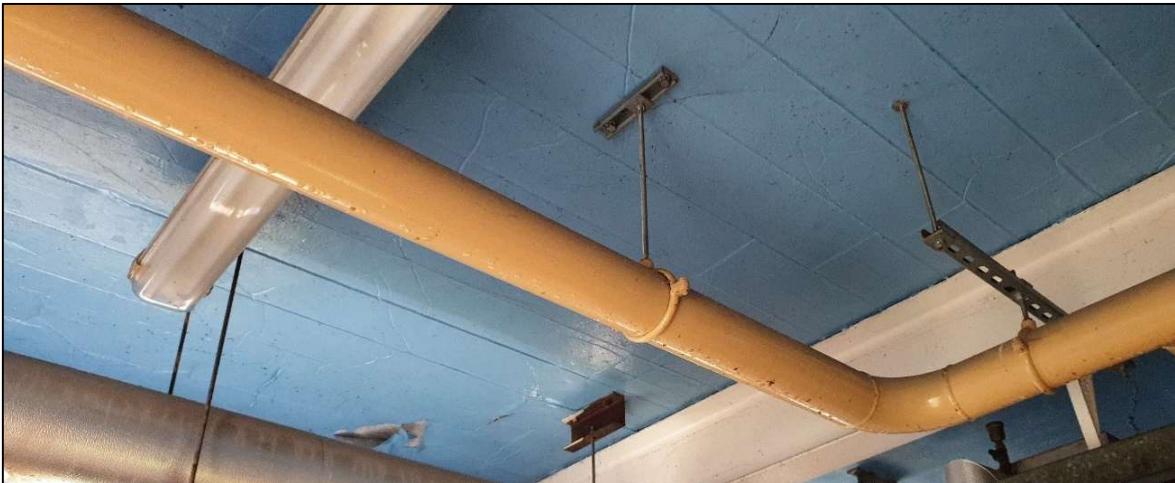
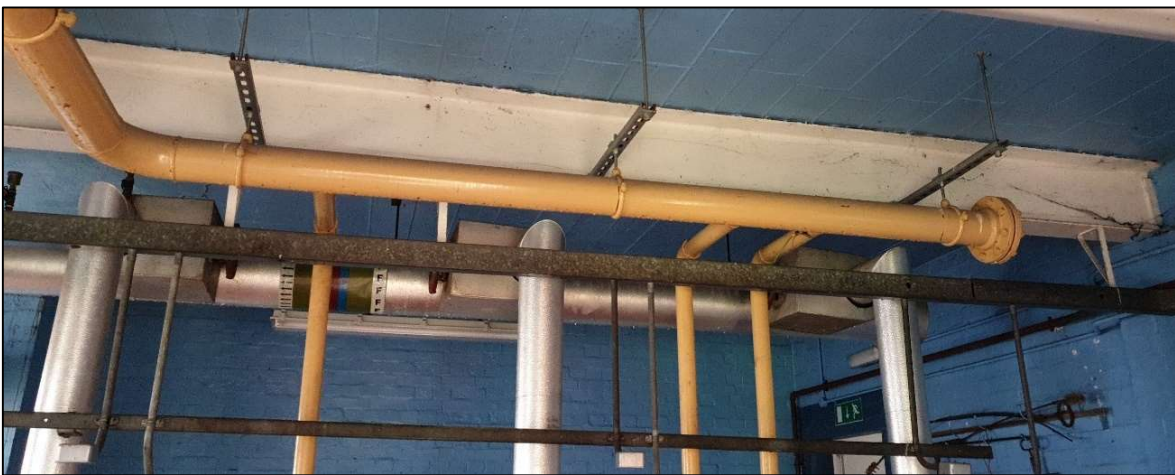
*Figure 7: 4-inch gas pipework showing end plate and 2-inch boiler feed pipes*

Three separate 2-inch boiler lines ran down from the 4-inch suspended manifold pipe. The route of one of these 2-inch pipes is shown in Figure 8 and Figure 9. Each of the 2-inch lines included ball valves, purge and test points and a series of welded and threaded fittings and elbows.

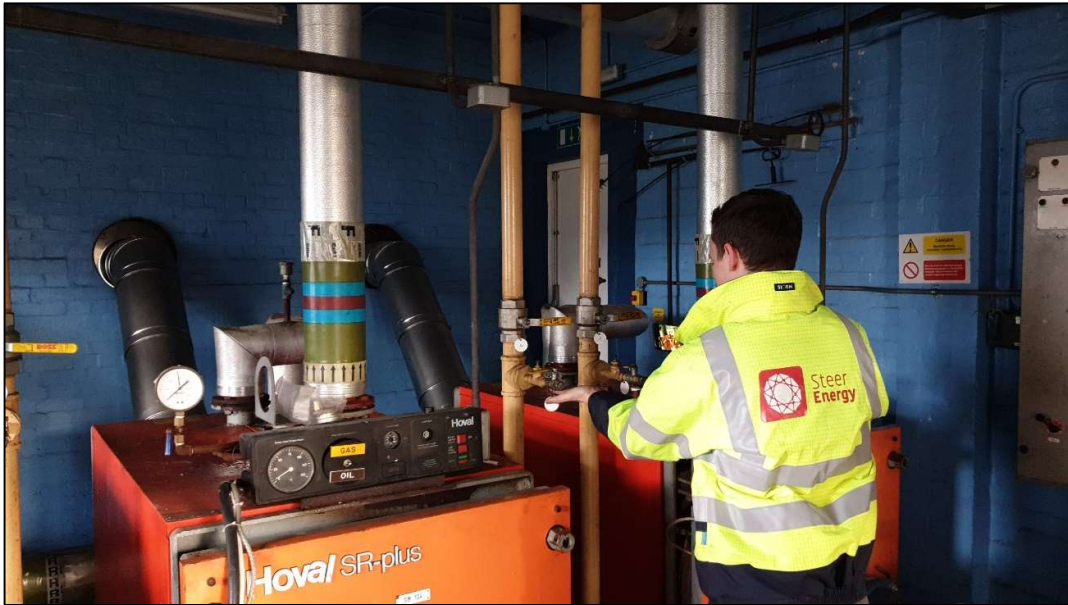
*Figure 12: Second and third boilers*

The building contained three oil / gas fired boilers, associated water systems and control systems. These are shown in Figure 11 and Figure 12.

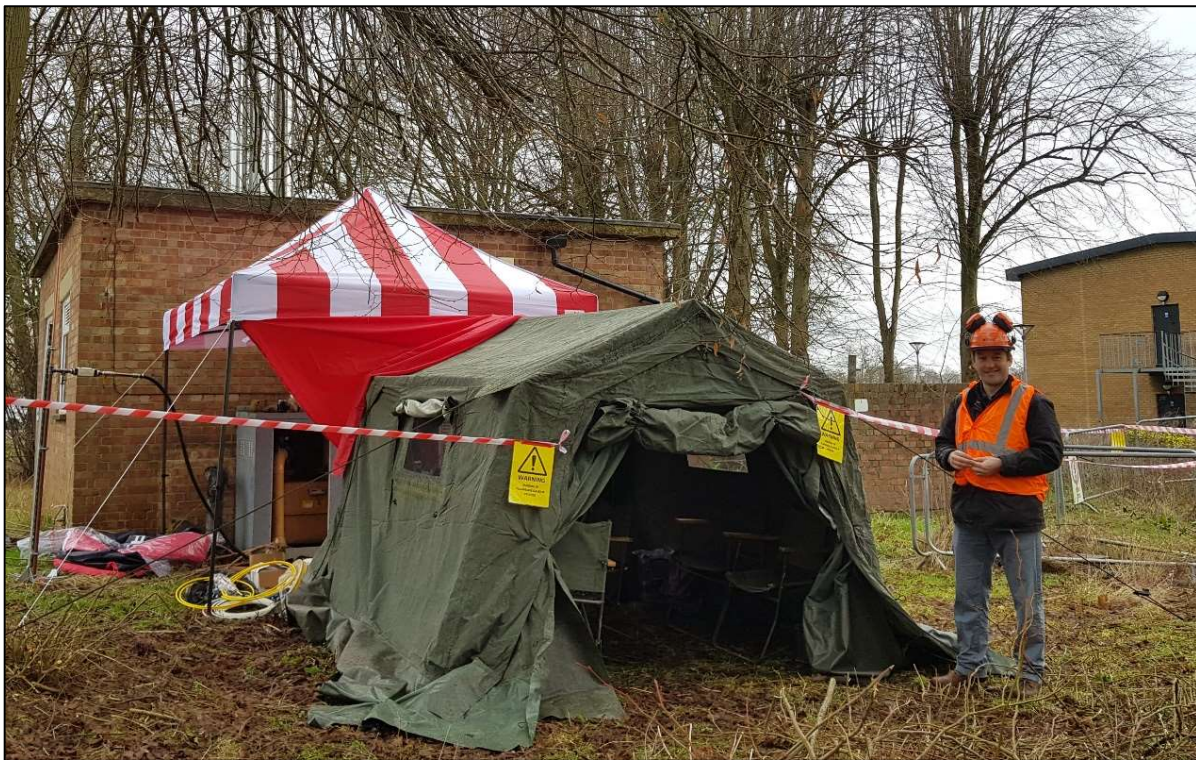
*Figure 13: South side of the plant room with shelter and warning perimeter*

Flammable gas was the main risk to personnel during the operations. The site was appropriately labelled with warning signs and bunting put up to restrict access to the site. Slips, trips and falls were highlighted as a risk on the 9 January 2020 site visit. This risk was minimised by cutting back undergrowth and overhanging branches. A path was cleared to the car park for transport of equipment to and from the plant room. A tent and a gazebo provided a dry and sheltered working environment for the equipment and personnel. Ground sheeting was used to stop the ground churning into mud. It was pegged along the edges to minimise the trip hazard.

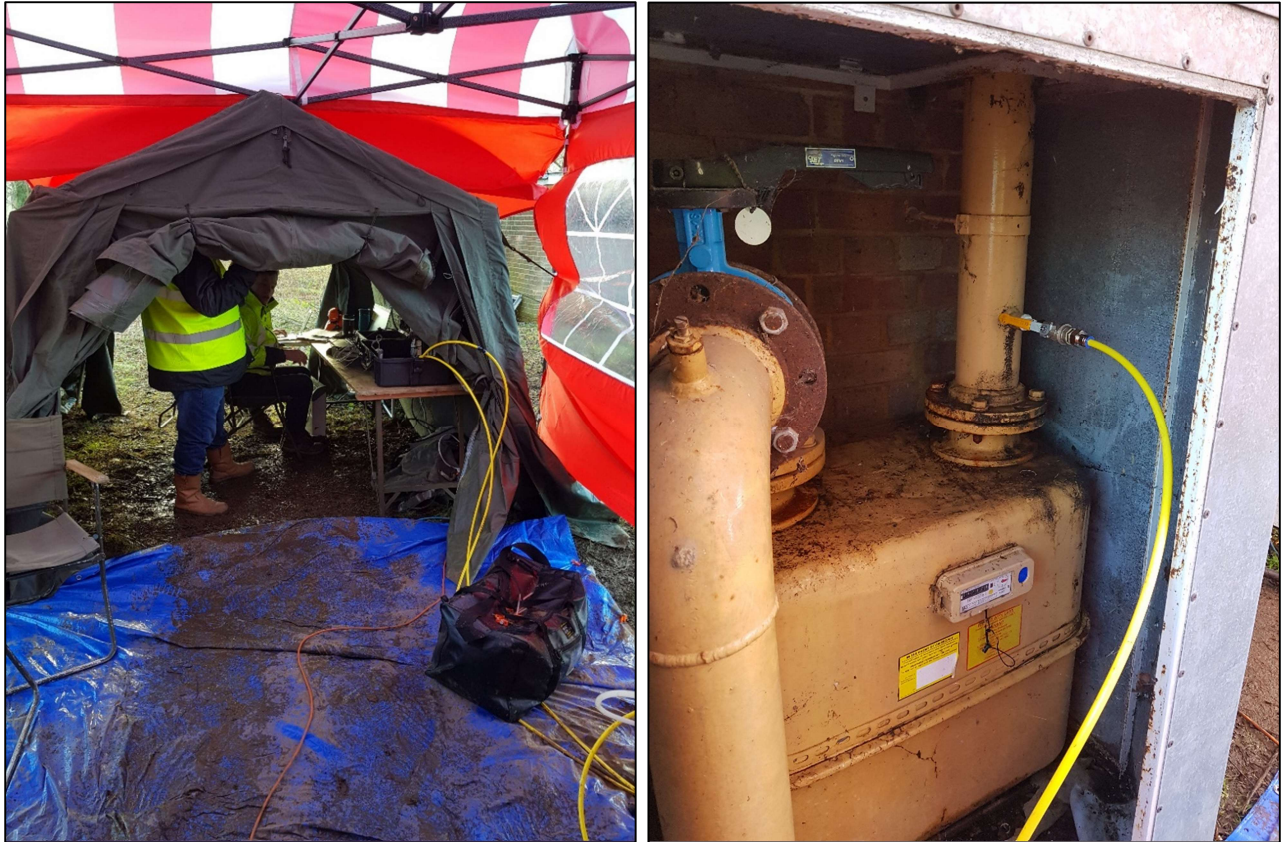
*Figure 16: Hose management from test equipment through to gas injection point*

The site visit on 9 January 2020 visit highlighted challenges of the working situation during a rain storm. In the enclosed space of the plant room. There was a clear risk of catching cables and hoses, posing a trip hazard and a risk to test equipment. During the second site visit, a walkway was established with loose cables and hoses tied down to minimise the risk of tripping while crossing the walkway.

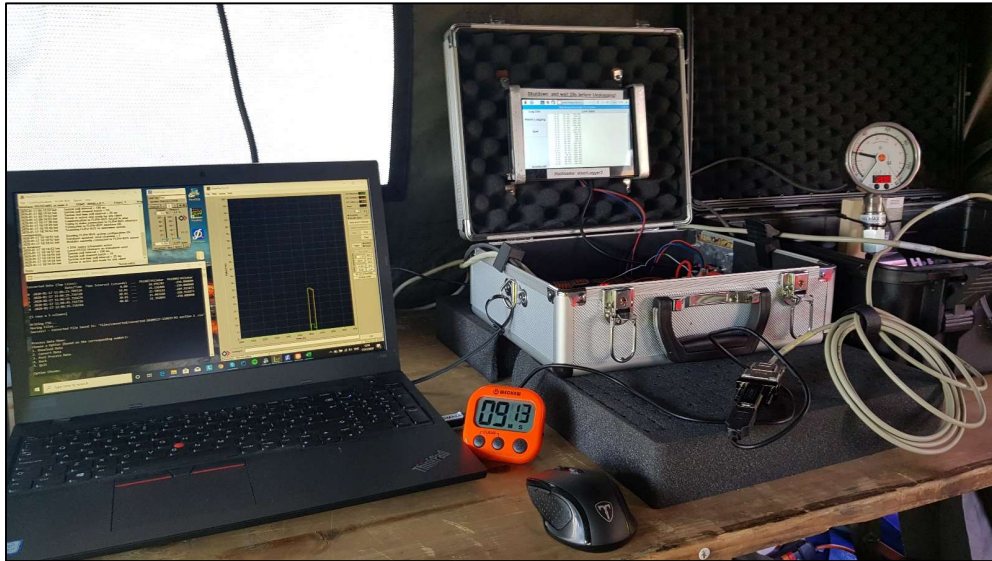
Figure 17: Electronic equipment set up

Additional lighting was placed inside the plant room and the tent to assist with visibility. The SOV, labelled 5 in Figure 20, is sprung closed and required external power to open. This was done by re-routing the original supply cable, wiring it to a standard three-pin plug and plugging into a switched RCD extension cable. Power was also required for the flow controllers, pressure gauge and laptop chargers. This was supplied by running an extension lead from a nearby boiler room. Two tables and a set of chairs provided comfortable working conditions and a stable platform for the sensitive test equipment. The test equipment layout is shown in Figure 17.

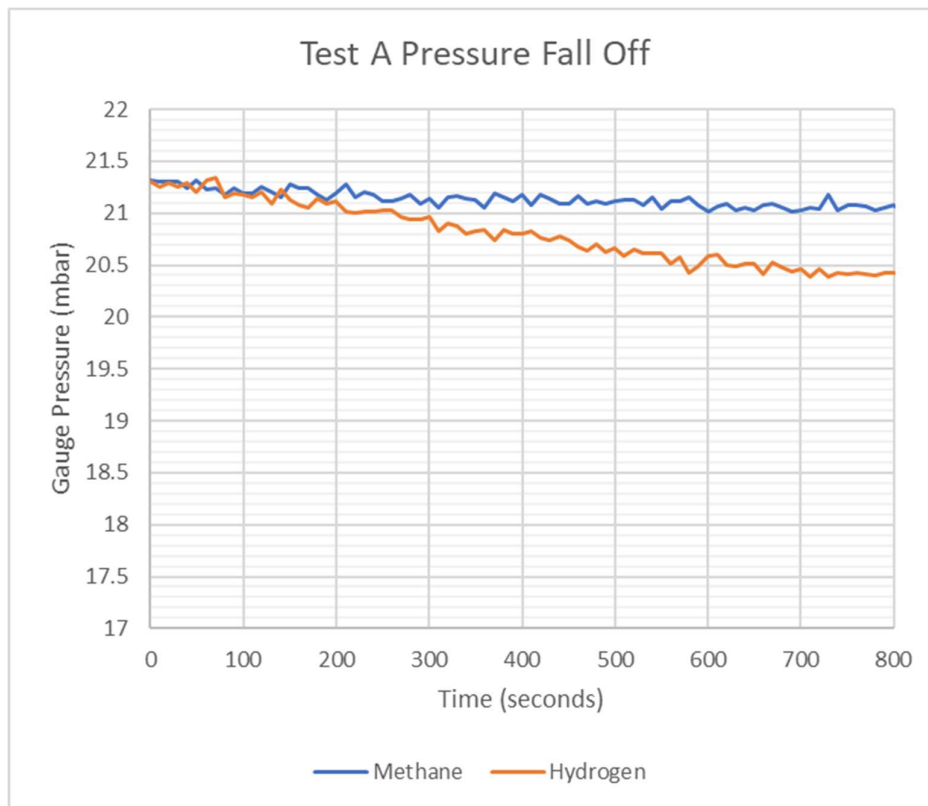
Figure 26: Test A pressure fall off graph

Test A examines leakage from section 1.

Test A results show very low levels of leakage from the system. Comparison of the two gases indicates that the hydrogen leakage was significantly more than methane leakage. A leak of this magnitude at 20 mbar is likely to be in laminar flow, and can be expected to produce a hydrogen to methane ratio of 1.2:1. One possible cause for this discrepancy is the possibility that there was unvented pressure in the system when tested in methane, so the pressure drop over the SOV was not fully 20 mbar. If this is the case it would indicate a leak passing through the SOV, which is not seen in methane due to pressure both sides of the valve. Alternative theories are that stroking the SOV changed the system between the two sets of test runs. It was also stroked before the input of methane however so any major changes would be expected to be already present. Other possibilities include temperature and pressure weather effects, wind affecting the measuring equipment and insufficient gas stabilisation time. The leakage rates are very small in both methane and hydrogen, so external factors such as sunlight on external pipes could have a noticeable effect.

Methane	Hydrogen
System volume (m <sup>3</sup> )	0.324	0.324
Pressure loss (mbar)	0.28	0.91
Time (mins)	13	13
Leak rate (m <sup>3</sup> /hr)	4.1 x10 <sup>-4</sup>	1.3 x10 <sup>-3</sup>
Leak rate (ml/hr)	411	1,327
H <sub>2</sub> : CH <sub>4</sub> ratio	3.22

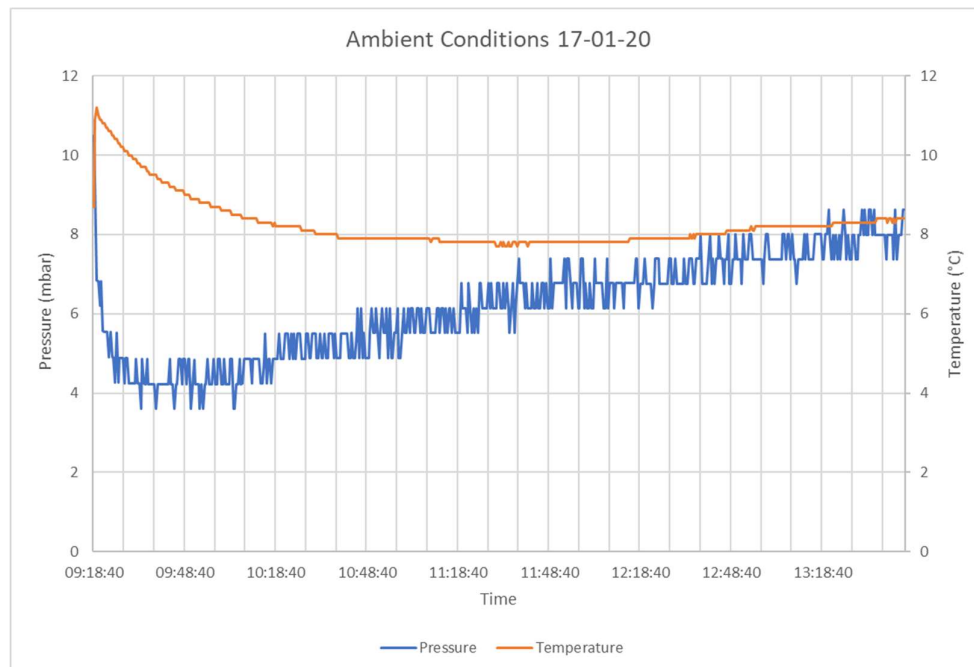
*Figure 34: Ambient conditions 17 January 2020*

The ambient pressure and temperature were logged on 17 January and shown in Figure 34, this indicates that although the weather was windy, there was not a significant swing of pressure or temperature over the test period. Periods of sunshine on external pipework may well have a greater effect on internal system pressure.

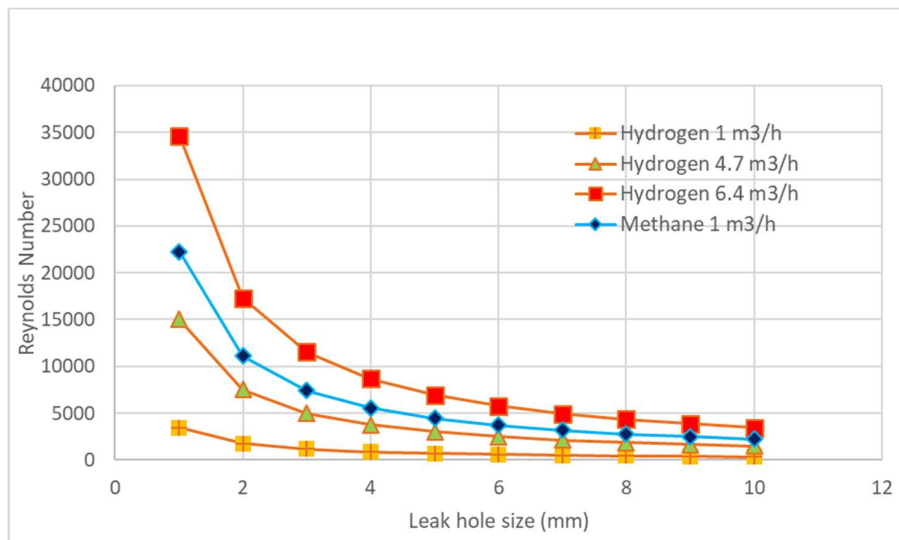
Figure 42: Demonstrating how Reynolds number changes with leak size

Similar to the methodology used above, we can calculate when turbulent flow is likely to occur through a leak. In the case of a 6 mm diameter leak, this is likely to occur at a flow rate of 0.67 m³/h for Methane and 4.3 m³/h for Hydrogen. Figure 42 outlines how Reynolds number changes as the leak hole sizes increase for a range of flow rates in Hydrogen and Methane.
