Safety Assessment: Experimental Testing – Ignition Potential

Document No.: 636105

Project name: Hy4Heat WP7 Lot 4. GL Industrial Services UK Ltd.
Report title: Ignition Potential Testing with Hydrogen and Methane Region UK
Spadeadam Research and Testing
Customer: Department for Business, Energy & Industrial Strategy, 1 Victoria Street, SW1H 0ET, London, United Kingdom MoD R5, Gilsland, Brampton, Cumbria CA8 7AU United Kingdom
Customer contact: c/o Sophie Brown, Arup Tel: +44(0)16977 47404
Date of issue: 2020-01-20
Project No.: 10158500
Organisation unit: Project Delivery
Report No.: 1, Rev. FINAL 1
Document No.: 636105

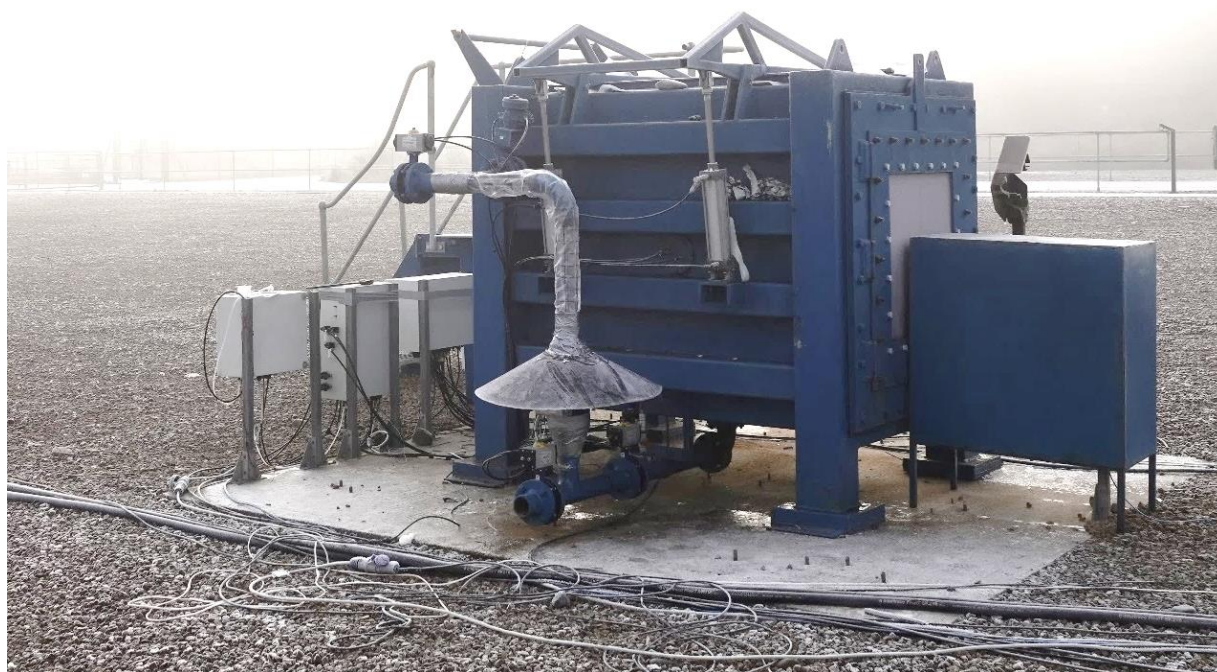
Each item was tested by placing it in a sealed explosion chamber and activating it once a flammable atmosphere had been established in the chamber. The explosion chamber used for these experiments is shown in Figure 1. It had a volume of 2.86 m³ (internal dimensions of 1.4 x 1.2 x 1.7 m).

Figure 1 - Explosion chamber used for ignition potential experiments

The explosion chamber was filled using a recirculation system in which the mixture in the chamber was extracted into external pipework loop and then returned to the chamber at a different location and elevation. Hydrogen or methane was introduced by injecting the gas into the recirculation loop. The continual recirculation process provided a homogenous mixture. Well-mixed gas mixtures do not separate (see for example [1]). This meant that the recirculation system can be switched off before testing without worrying about losing the homogeneity of the mixture. A well-mixed hydrogen air mixture will have much lower density than normal ambient air, meaning that if the explosion chamber needed to be well sealed to prevent the mixture becoming lean through buoyancy driven ventilation.

Items were placed into the chamber through the roof which was opened and closed via pneumatically driven rams. The roof was an open frame that clamped down a plastic sheet onto the sides of the chamber. The plastic sheet is an intentional venting pathway: when an explosion occurs, the plastic sheet will fail, and the combustion products vent vertically upwards.

For a vent of this size, the plastic sheeting fails at an overpressure in excess of 70 mbar. In context, Mathurkar [2] as a part of the HySafe project, investigated the ignitability of hydrogen and methane in

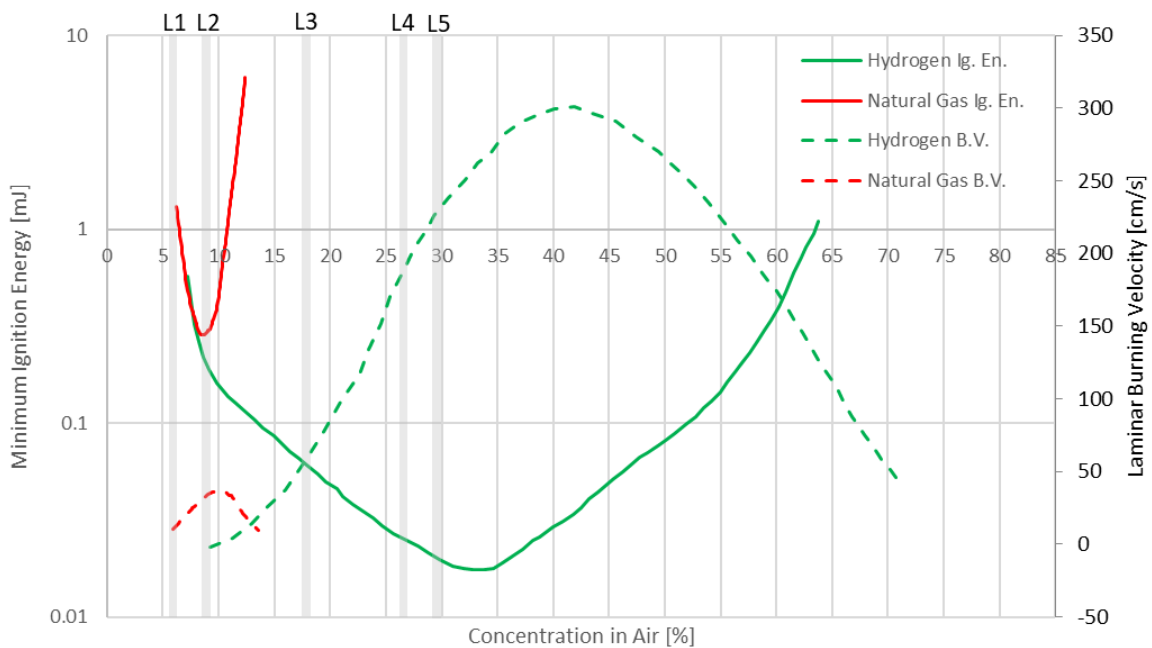
Figure 2 shows representative minimum ignition energy and laminar burning velocity data for both hydrogen and methane as a function of gas concentration. The minimum ignition energy data has been reproduced from [2], and the hydrogen laminar burning velocity from [3].

Figure 2 – Representative minimum ignition energies and laminar burning velocities of hydrogen and methane as a function of volumetric gas concentration. Ignition energy reproduced from [2], hydrogen burning velocity [3], methane burning velocity [4].

Figure 2 also shows the concentration levels used in these tests. Each nominal concentration level is associated with an experimental range of +/- 0.3%. This figure (and Table 2) shows that hydrogen is ignitable over a much wider concentration range than methane. The figure also shows that hydrogen has a much lower ignition energy than methane and a much higher laminar burning velocity. Most importantly the figure shows that the progression of the five hydrogen nominal concentration levels for hydrogen, and the two nominal concentration levels for methane correspond to progressively lower ignition energies and progressively higher laminar burning velocities. In other words, they correspond to progressively more dangerous mixtures. The figure also shows that the higher methane concentration band aligns with the lowest part of the methane minimum ignition energy curve. Figure 3, expresses the data in Figure 2 in terms of equivalence ratio.

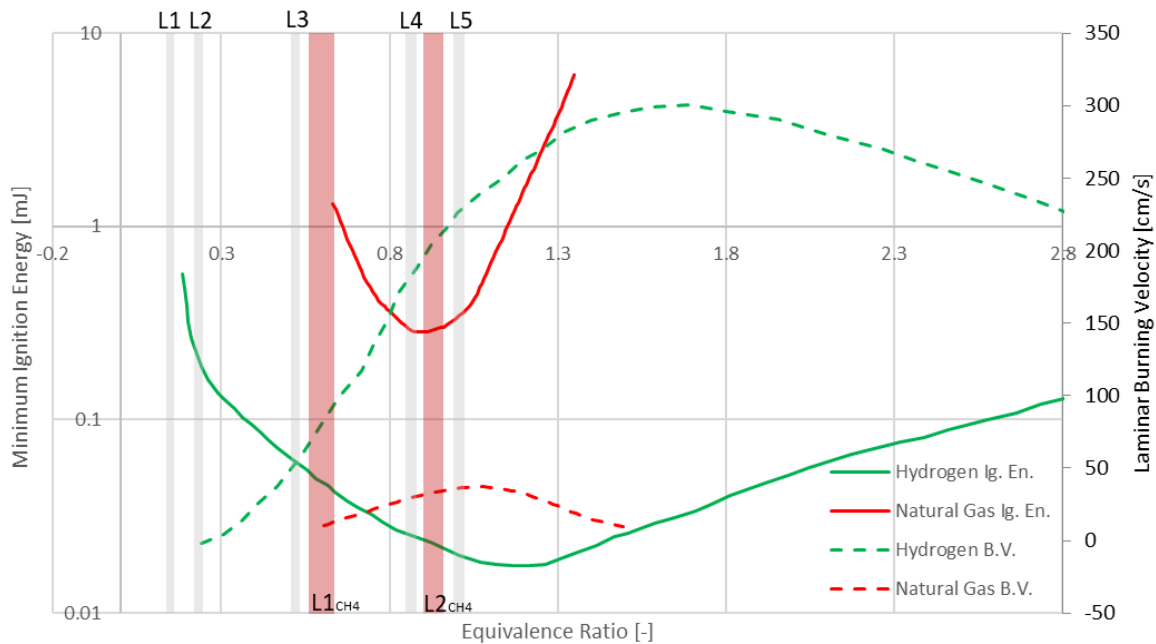
Figure 3 – Figure 2 expressed in equivalence ratio (representative minimum ignition energies and laminar burning velocities of hydrogen and methane as a function of Equivalence Ratio. Ignition energy reproduced from [2], hydrogen burning velocity [3], methane burning velocity [4]).

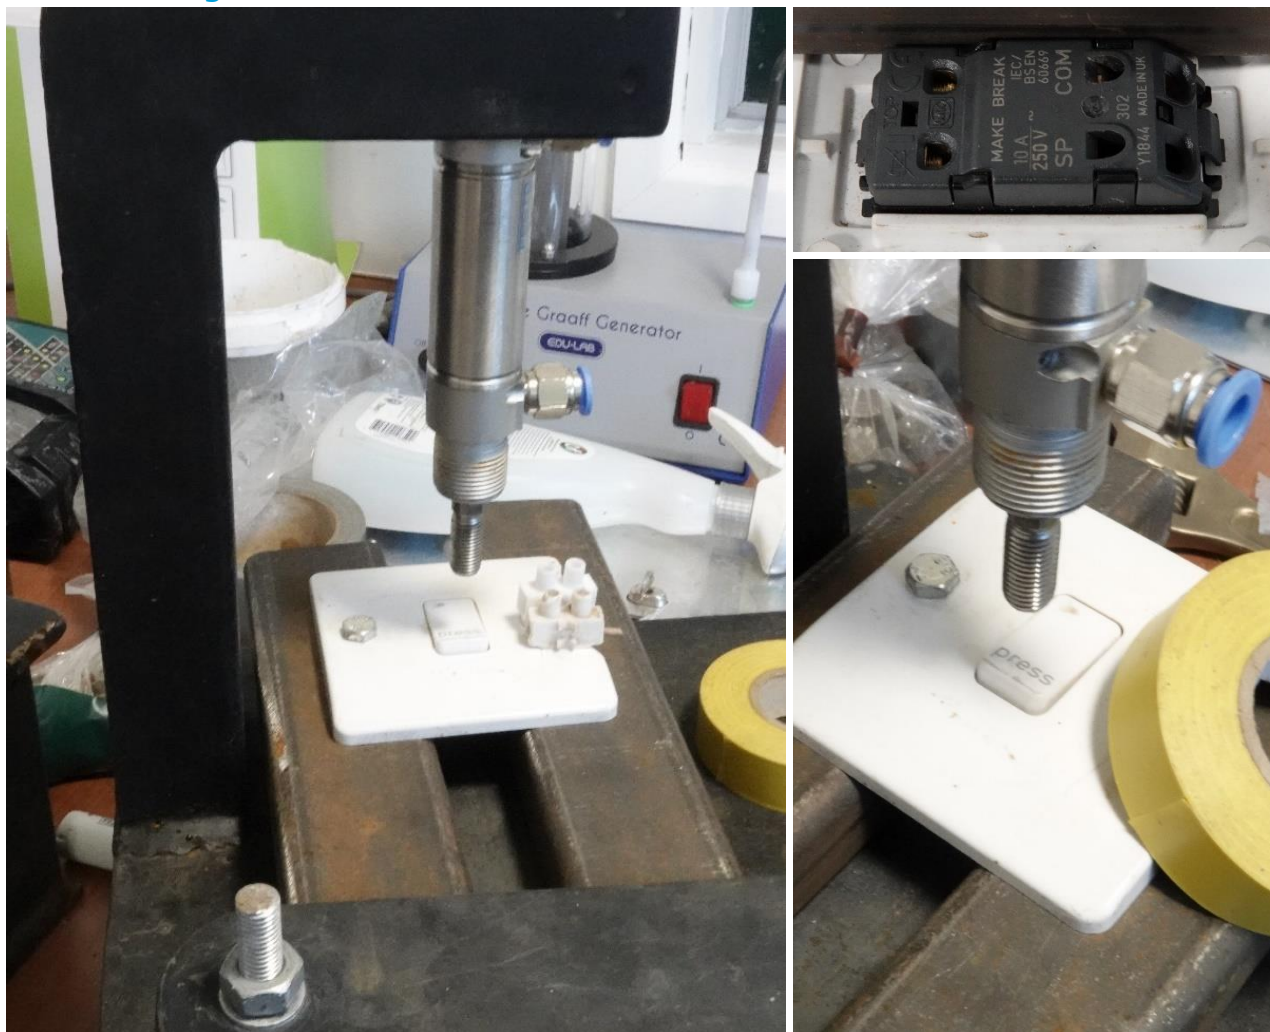
A2. Press Light Switch

Figure A.2 – Push light switch. Left: switch installed underneath a pneumatic ram. Upper right: connections on reverse side of switch. Lower right: closeup of ram over switch.

A plastic light switch was chosen to be representative of a domestic press light switch. The switch was spring return rather than the normal domestic “2-state” type.

With hydrogen the pressing action was found to cause ignition when connected to the following electrical items: hair dryer, and microwave. Ignition occurred at the lowest hydrogen concentration: L1.

With methane, the highest electrical load (hair dryer) failed to cause ignition at any concentration level.

Visual inspection carried out during and at the end of the test programme did not find any marks that could be attributed to the presence of combustion or the ignition of an explosion.

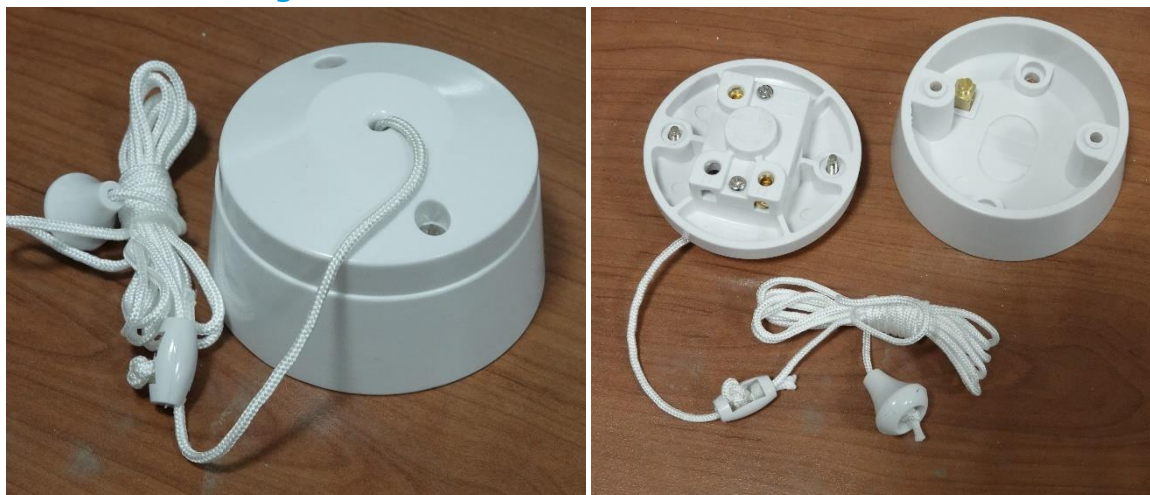
A3. Pull Cord Light Switch

Figure A.3 – Pull cord light switch. Left: switch before tests. Right: underneath of switch with base removed.

A pull cord light switch was procured from a local hardware store and taken to be representative of a domestic pull cord switch (possibly for use in a damp environment such as a bathroom). The base unit was removed, and the pull cord was attached to the pneumatic ram (see plug socket and press light switch above), with the switching unit held down so that the ram pulled the cord. The switch was located near the floor of the explosion chamber.

With hydrogen the activation action was found to cause ignition when connected to the following electrical items: hair dryer, microwave, and fluorescent bulb. Ignition with the fluorescent light took 42 cycles, but did not occur with the 60 W bulb at any concentration. When ignition occurred, it did so at the lowest hydrogen concentration: L1.

With methane, the highest electrical load (hair dryer) failed to cause ignition at any concentration level.

Visual inspection carried out during and at the end of the test programme did not find any marks that could be attributed to the presence of combustion or the ignition of an explosion.

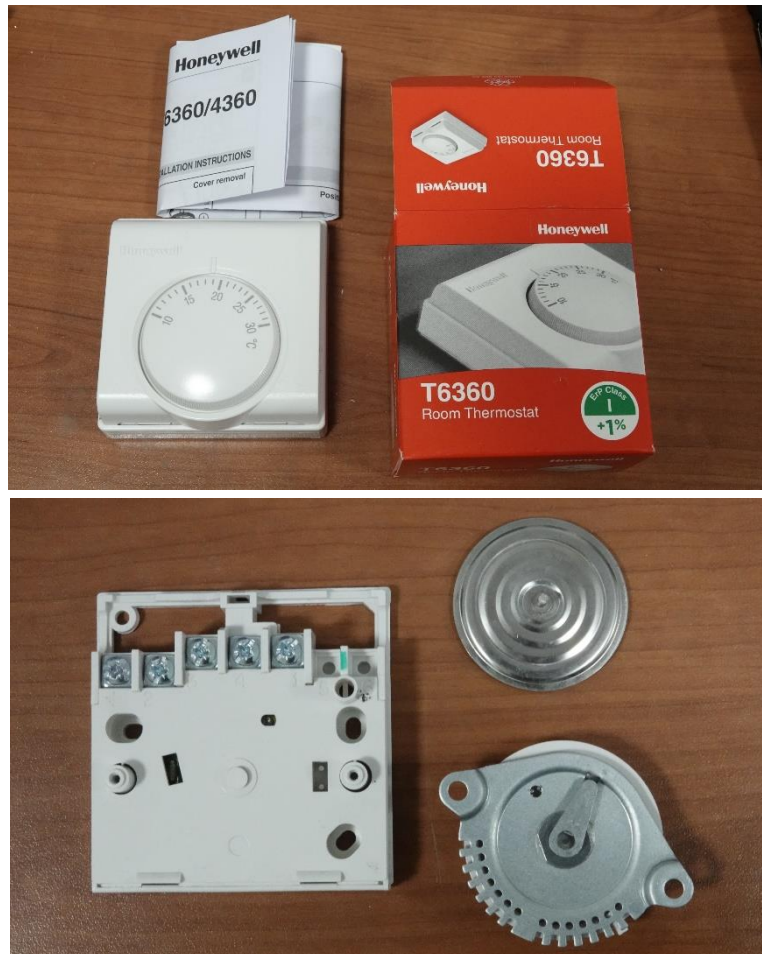
A4. Thermostat

Figure A.4 – Thermostat. Upper: thermostat unboxed showing outer casing. Lower: internals of thermostat showing internal switch (small circle in centre of unit).

A Honeywell T6360 room thermostat was procured to represent a typical domestic thermostat. It was attached to a metal table directly underneath the pneumatic ram. The outer cover and control dial mechanism were removed exposing the internal switch (small white circle in centre of unit).

With hydrogen the switching action was found to cause ignition when connected to the following electrical items: hair dryer, microwave, and fluorescent bulb all caused ignition. Ignition occurred at the lowest hydrogen concentration: L1.

Visual inspection carried out during and at the end of the test programme did not find any marks that could be attributed to the presence of combustion or the ignition of an explosion.

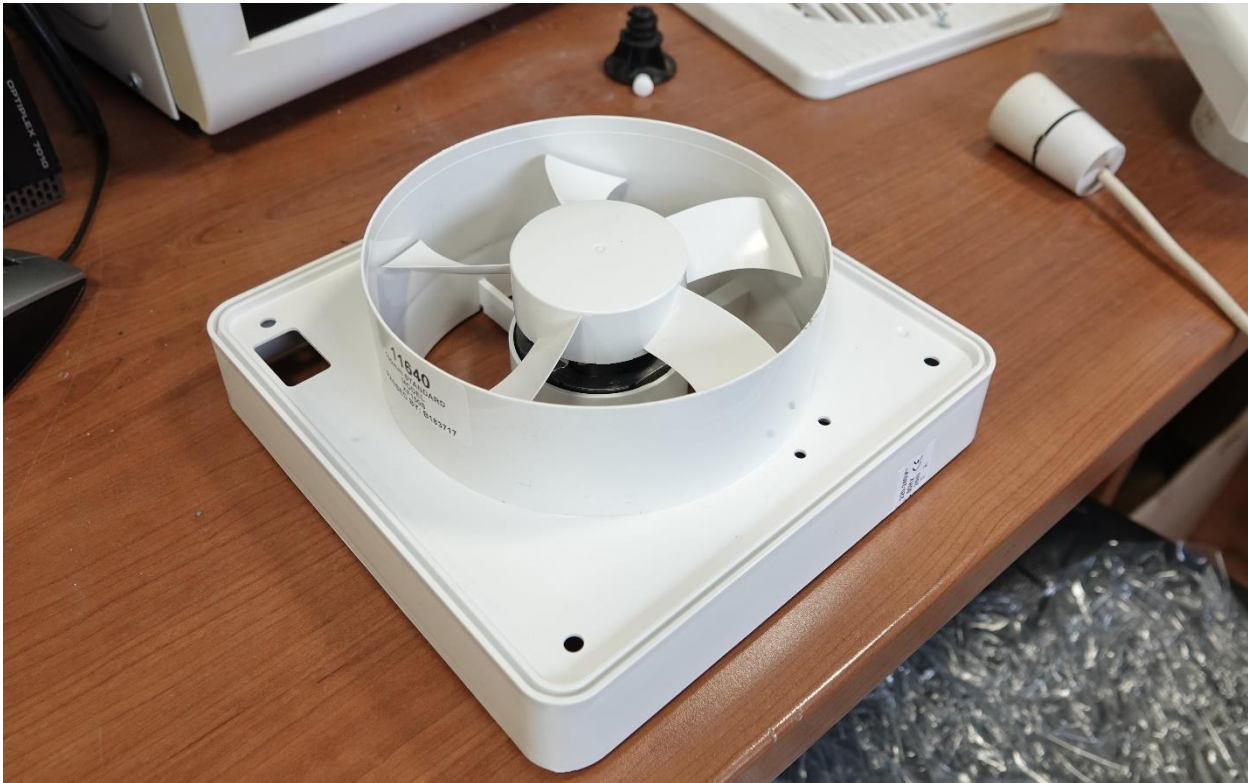
A5. Small Extractor Fan #1

Figure A.5 – Manrose 11640 extractor fan unit.

A Manrose 11640 extractor fan unit was procured and assumed to be generically representative of small extractor fans in their as-new condition. The unit was switched on and off from outside the enclosure.

The fan unit did not ignite hydrogen at any concentration. Because it did not ignite hydrogen, it was not tested with methane.

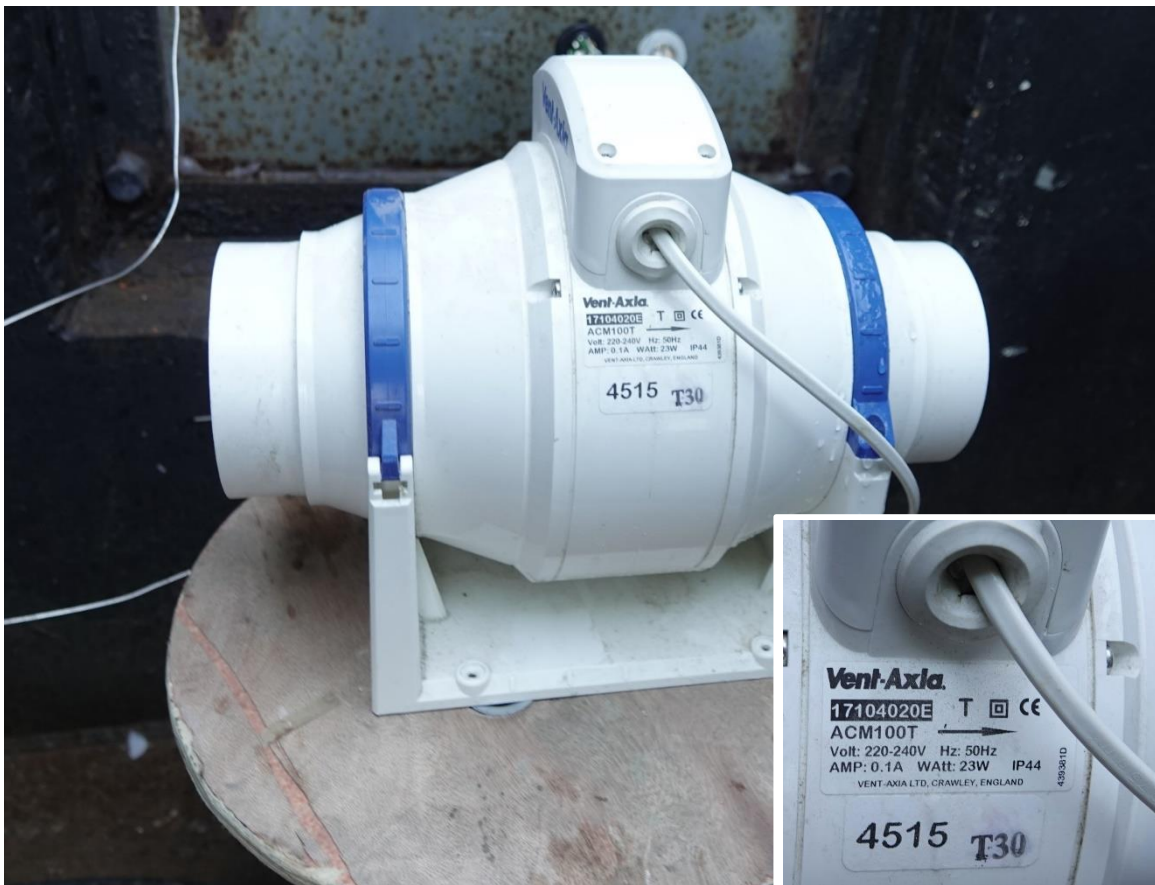
A7. Medium Sized Extractor Fan

Figure A.7 – Vent Axia 17104020E extractor fan unit. Upper: fan unit. Lower: label

A Vent Axia 17104020E was taken out of an old building. It was assumed to be generically representative of medium sized extractor fan in a used condition. It was hoped that in a used state, the electrical motor would be more likely to produce sparks.

The fan unit did not ignite hydrogen at any concentration. Because it did not ignite hydrogen, it was not tested with methane.

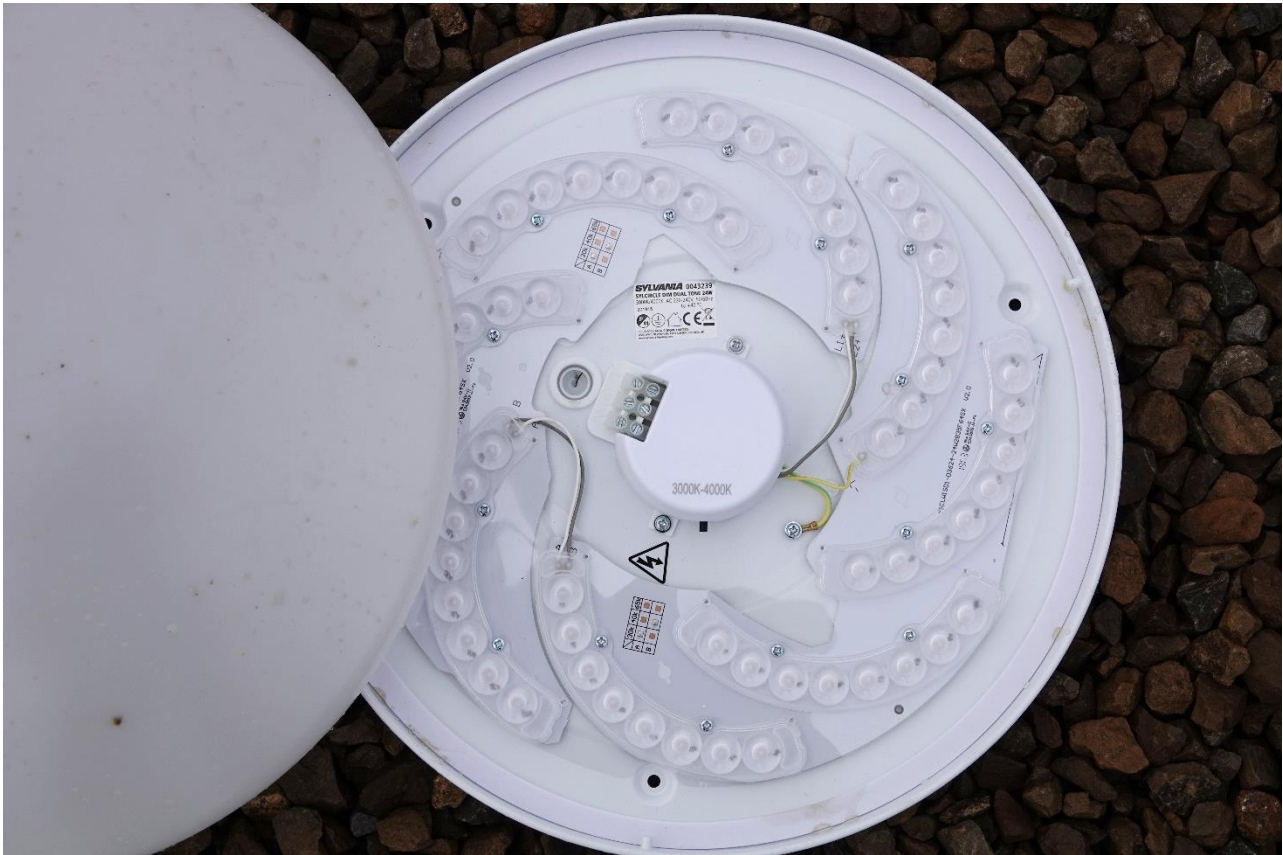
A8. Incandescent Light Fitting #1

Figure A.8 – 24W Sylvania 6412X Ceiling Light.

An LED ceiling light was procured and assumed to be representative of modern lighting, 24W Sylvania 6412X ceiling light.

It did not ignite hydrogen at any concentration. Because it did not ignite hydrogen, it was not tested with methane.

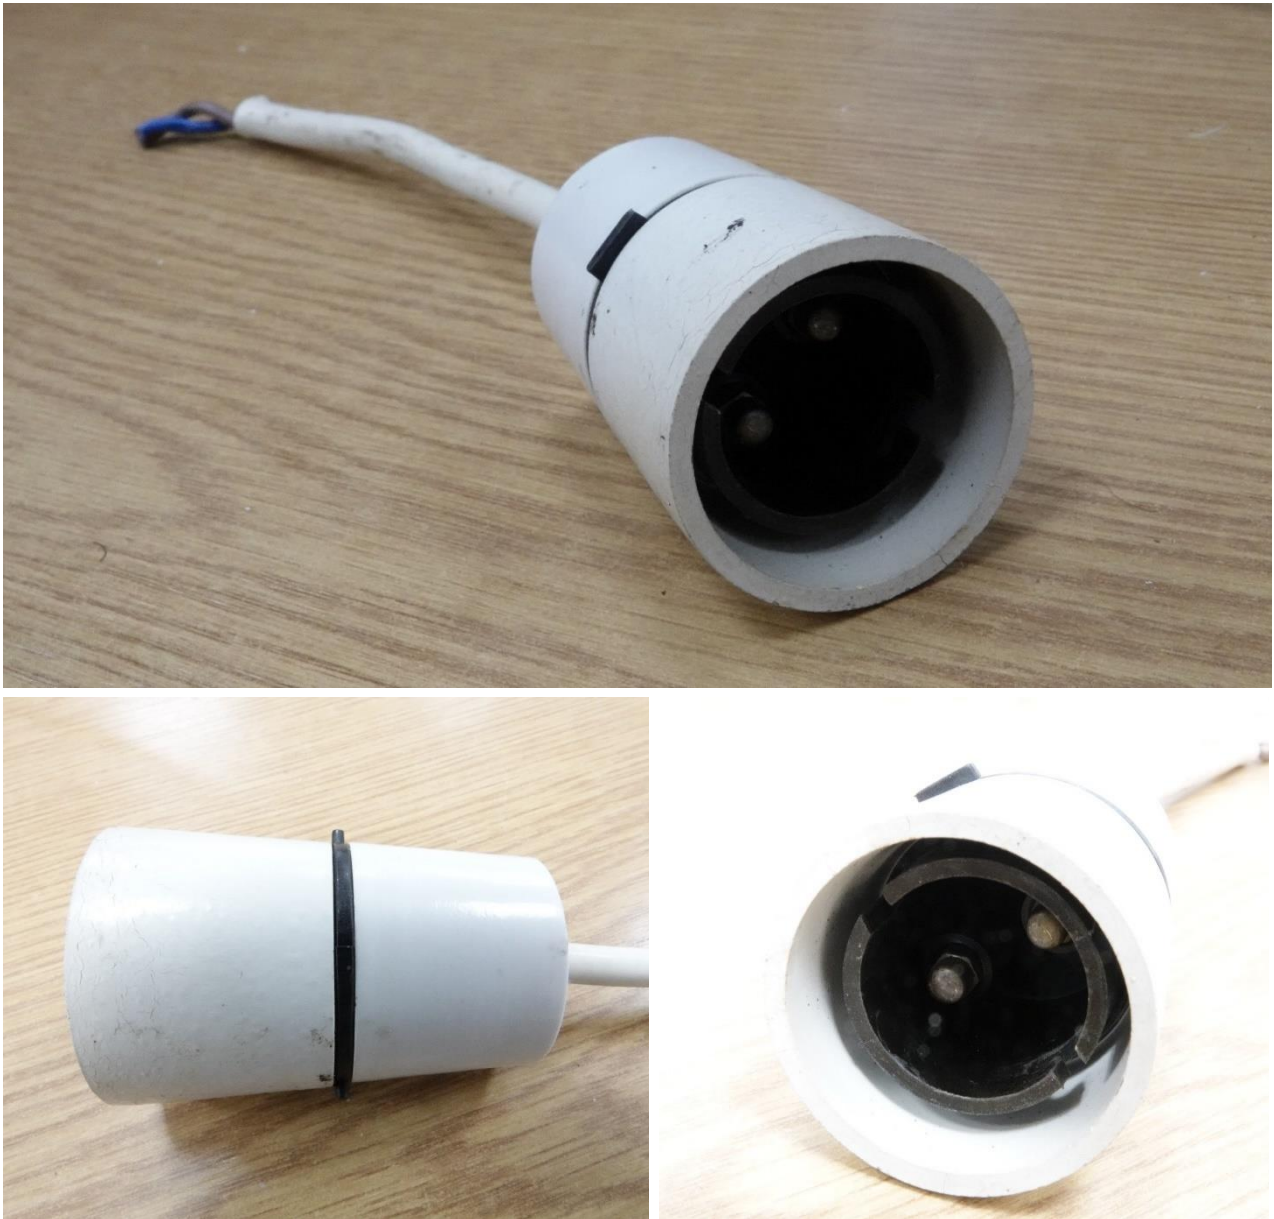
A9. Incandescent Light Fitting #2

Figure A.9 – Old bayonet light fitting.

An old bayonet light fitting was taken from a building. It was assumed to be generically representative of bayonet light fittings everywhere.

Ignition did not occur with hydrogen, so methane was not tested.

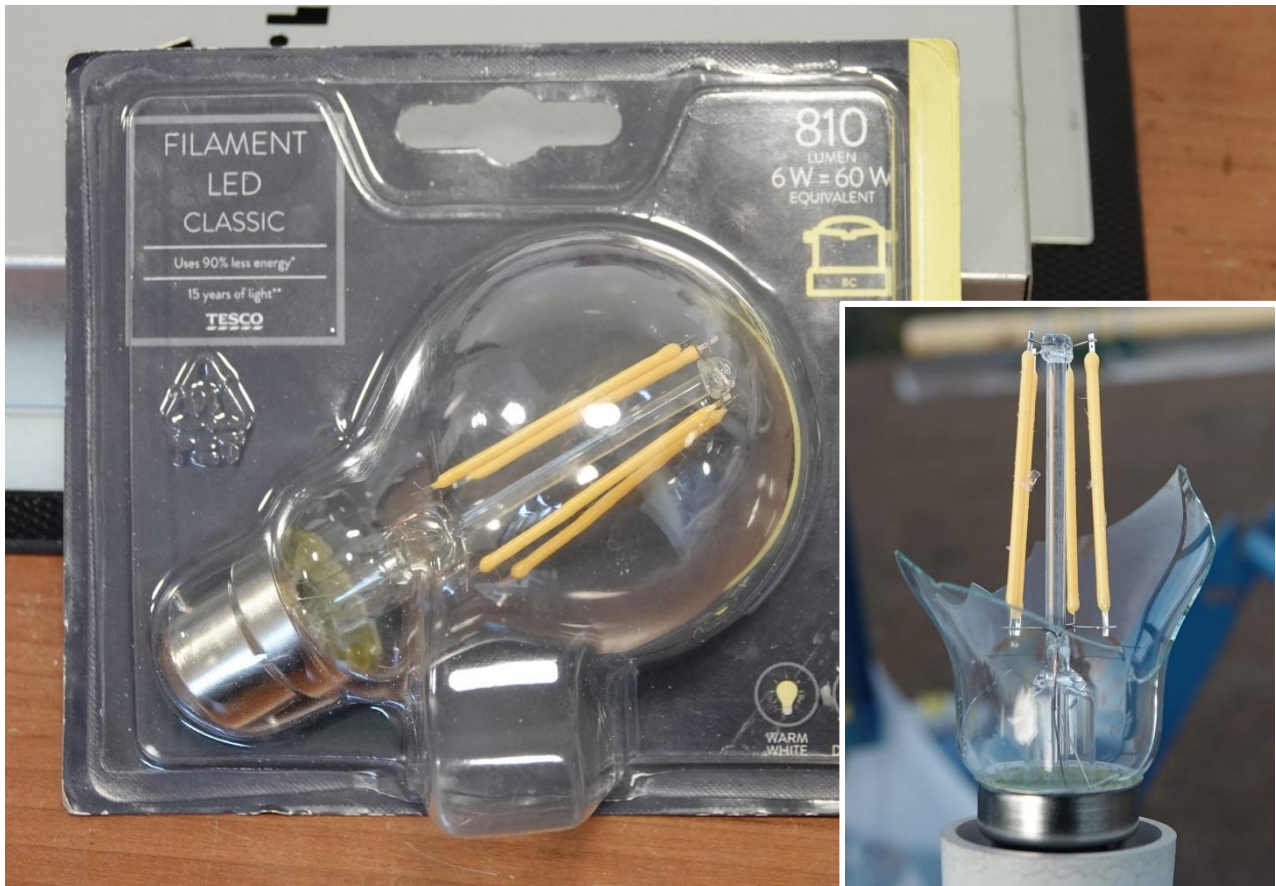
A10. LED Bulb

Figure A.10 – Modern LED Light bulb.

A modern LED lightbulb was used both as electrical load (into a bayonet light fitting (section A9) and as a potential ignition source with the casing smashed. Old fashioned (e.g. 100 W light bulbs) are known to be competent ignition sources when broken because the filament heats up and then melts causing a hot surface and possibly a spark. This LED bulb with the casing smashed, was tested as a comparison to a smashed 60 W light bulb.

It was activated on a 2 s cycle (i.e. 'on' for 2 seconds then 'off' for 2 seconds). It did not ignite hydrogen at any concentration. Because it did not ignite hydrogen, it was not tested with methane.

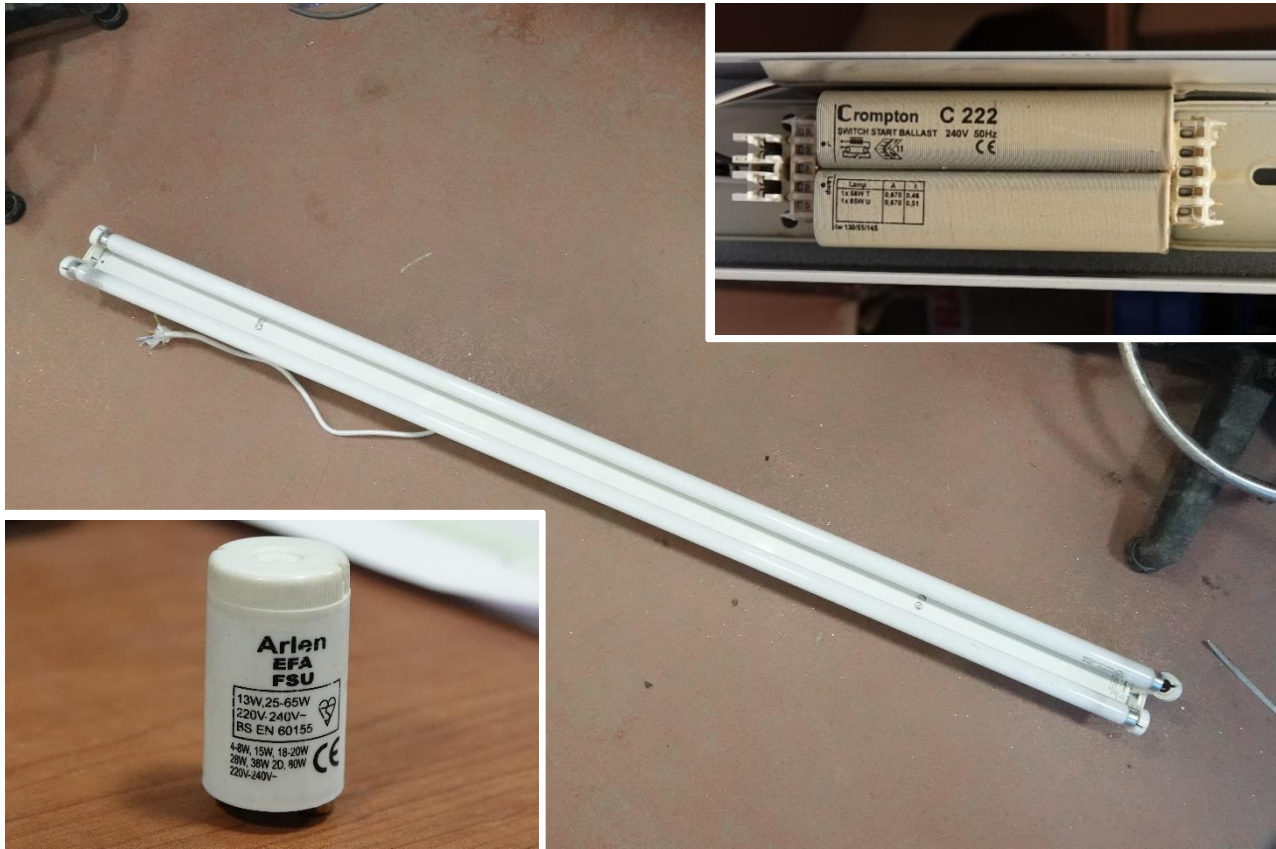
A12. Fluorescent Lights (#1 & #2)

Figure A.12 – Fluorescent light fitting. Centre: entire fitting. Lower left: ignitor

An aged fluorescent light fitting was removed from an old building. An old fitting was hoped to exhibit some sort of damage (possibly loose contacts) that might promote ignition. The light was activated from outside the explosion chamber meaning that the test did not satisfy the electrical contacts criteria of a competent ignition source. The fluorescent light was activated in a working condition and with a faulty ignitor. In both cases it was activated on a 7.5 s cycle (i.e. 'on' for 7.5 seconds then 'off' for 7.5 seconds).

Neither the working nor faulty condition caused ignition at any hydrogen concentration level and therefore it was not tested in a methane atmosphere.

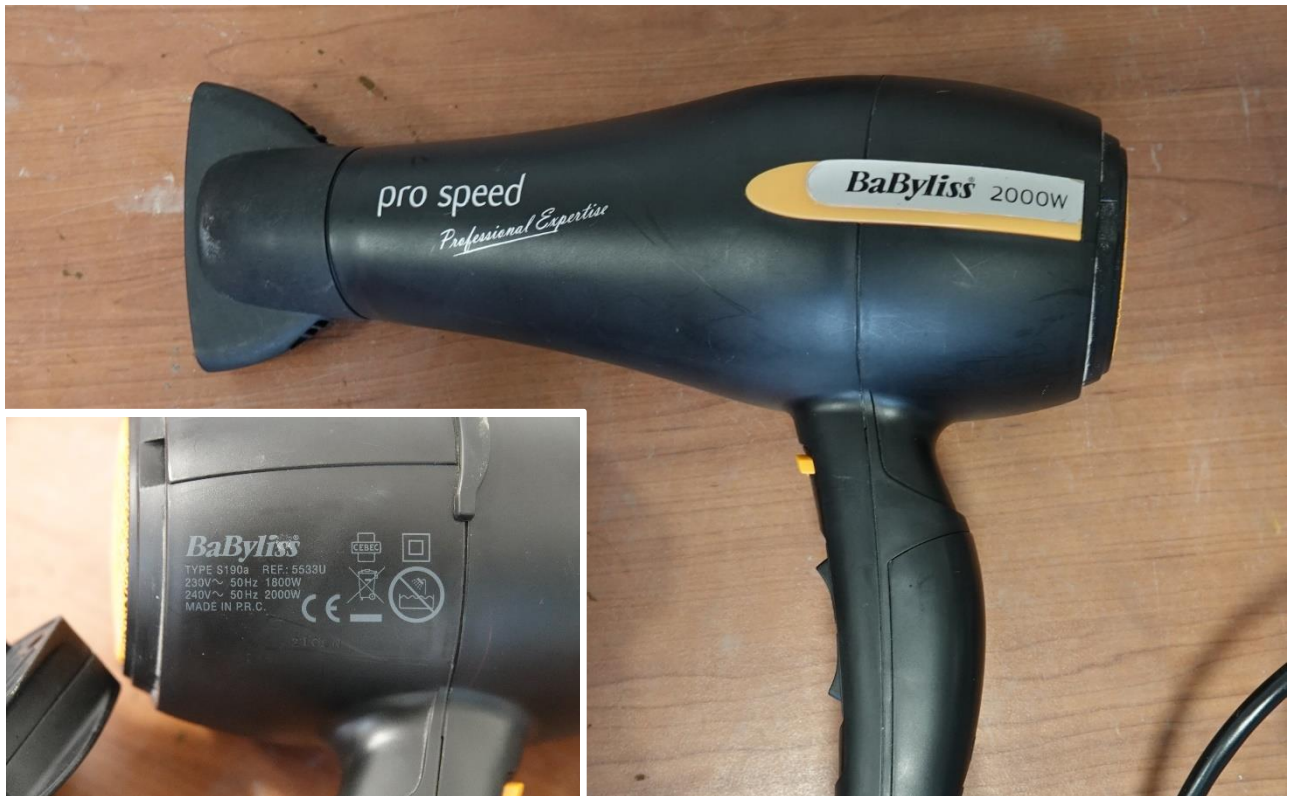
A13. Hair Dryer

Figure A.13 – BaByliss S190A hair dryer

A second hand BaByliss S190A hair dryer was procured to represent a common household item. It was installed into the explosion chamber in a switched-on state and activated by connecting the power remotely. Therefore, it fulfilled both the hot surface and the electrical motor criteria but not necessarily the electrical contacts. When switched on, and from cold, it took approximately 40 seconds to reach maximum temperature.

The hair dryer was inspected during and after the test programme. At no point were any damages observed.

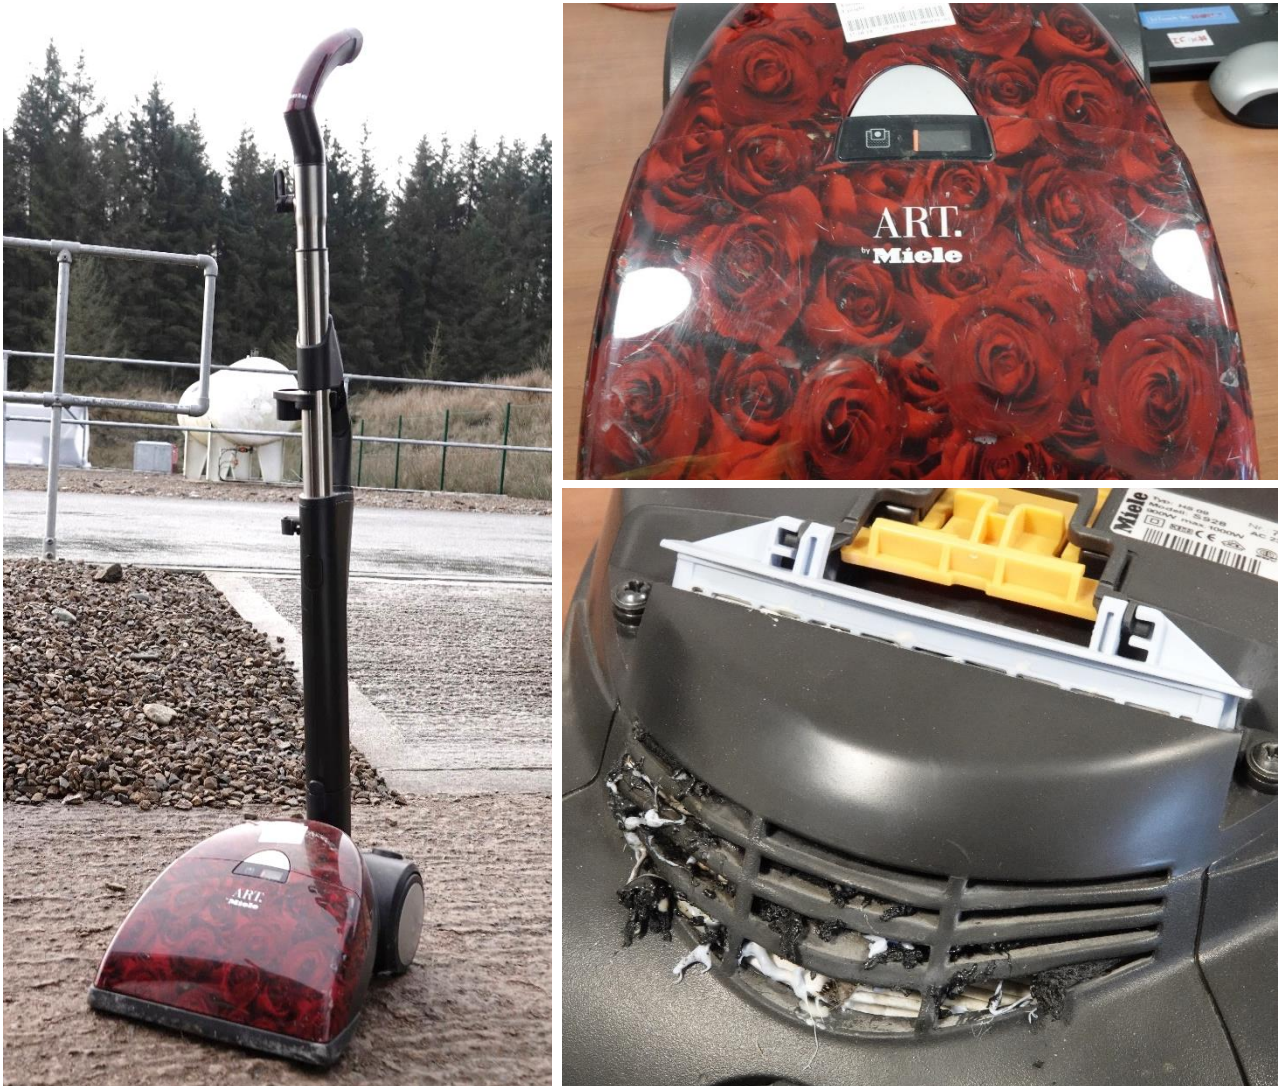
A14. Vacuum Cleaner

Figure A.14 – Old vacuum cleaner. Left: as tested state., Upper right: front of casing. Bottom right: filter slot showing melting and expansion damage.

An old Miele vacuum cleaner was procured to represent a used and common household item.

It was inspected during and after the test programme. Melting and expansion damage was observed at the filter slot, and the filter was partly pushed out of the plastic grill. It was not possible to remove the filter. It is suspected that this damage indicates that ignition occurred within the mechanism. Although some molten plastic was present, no sooting or charring was found.

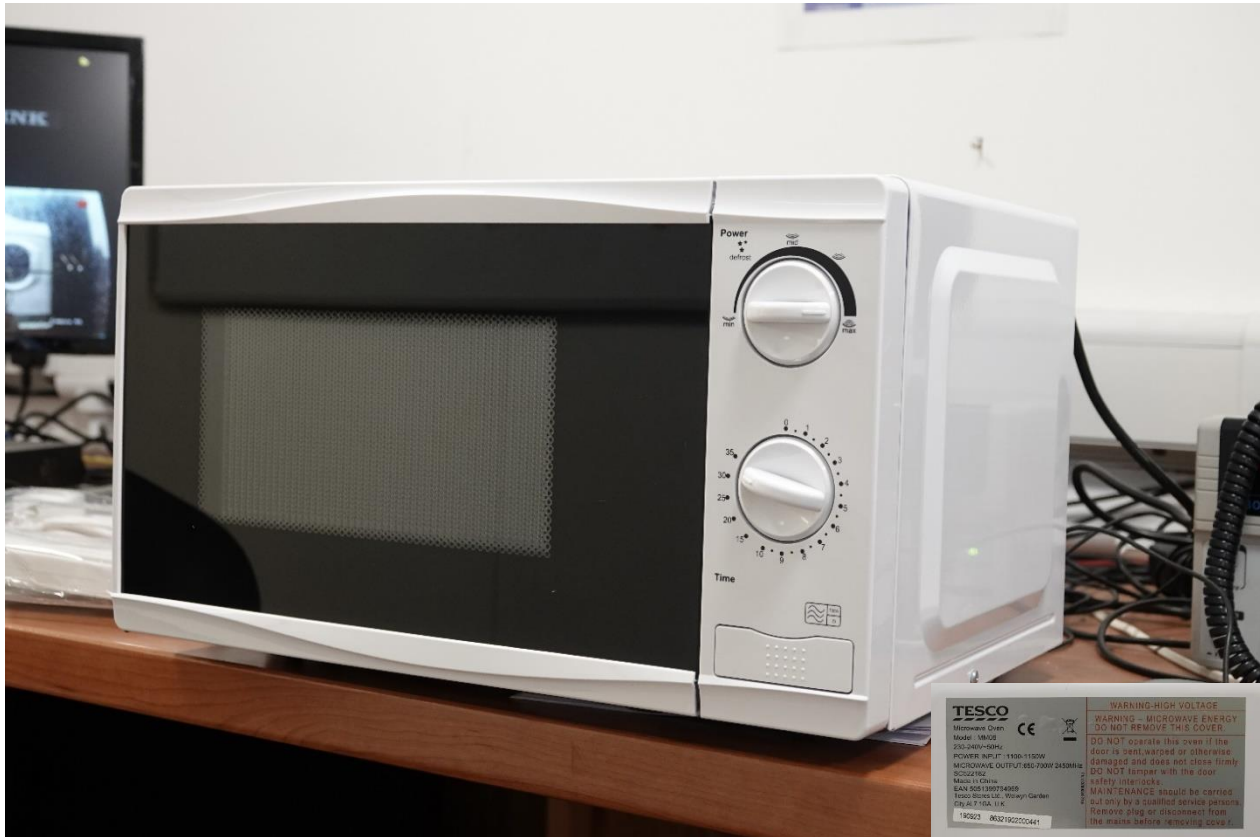
A15. Microwave Oven

Figure A.15 – Cheap Tesco non-programmable microwave. Left: as tested state., Bottom right: label.

An brand new Tesco microwave was bought to represent a common household item and also a high current device. It had manual dials for operation.

It did not cause ignition in hydrogen at any concentration and was not subsequently tested in methane.

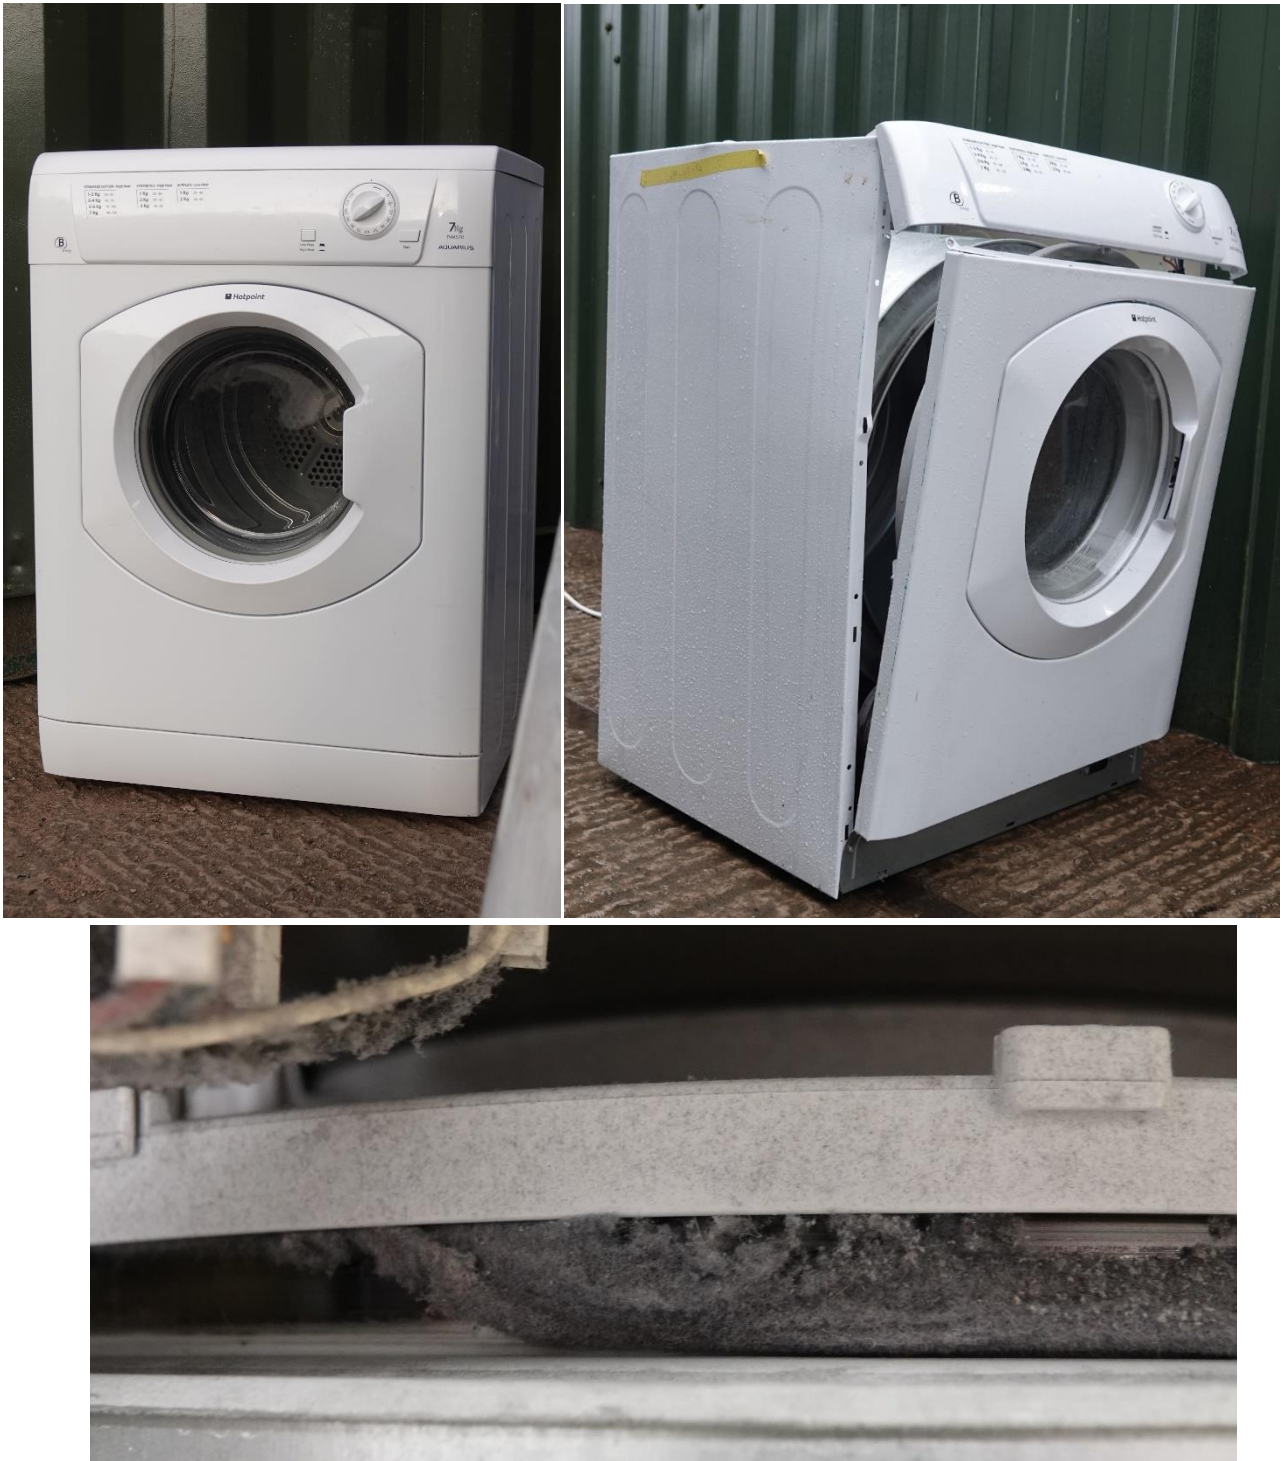
A16. Tumble Dryer

Figure A.16 – Hotpoint Aquarius TVM570. Upper left: as tested state. Upper right: after hydrogen explosion, Lower: separation of drum (upper) from chassis (lower).

Tumble dryers are a well-known source of fires [6] due to a tendency to collect fine dust and then deposit it on hot mechanisms. Their propensity to cause explosions is less well understood. A Hotpoint Aquarius TVM50 was procured as representative of a machine in a used condition. An initial inspection

It was not possible to fix the tumble dryer and so it was not tested with methane.

- It took a long time for some household items to ignite hydrogen. The tumble dryer ignited after 9 minutes operational time on L1 hydrogen, and the iron on L4 hydrogen. In both cases, the key process controlling ignition may not be operational time (or the concentration of hydrogen), but the ability of the hydrogen air mixture to diffuse into the device and reach the ignition source. In the case of the tumble dryer, it was noted that the concentration in the explosion chamber dropped out of acceptable range immediately upon activation, necessitating many hydrogen “top ups” before ignition occurred – indicative of the various voids within the device filling with mixture much slower than the chamber around the device.

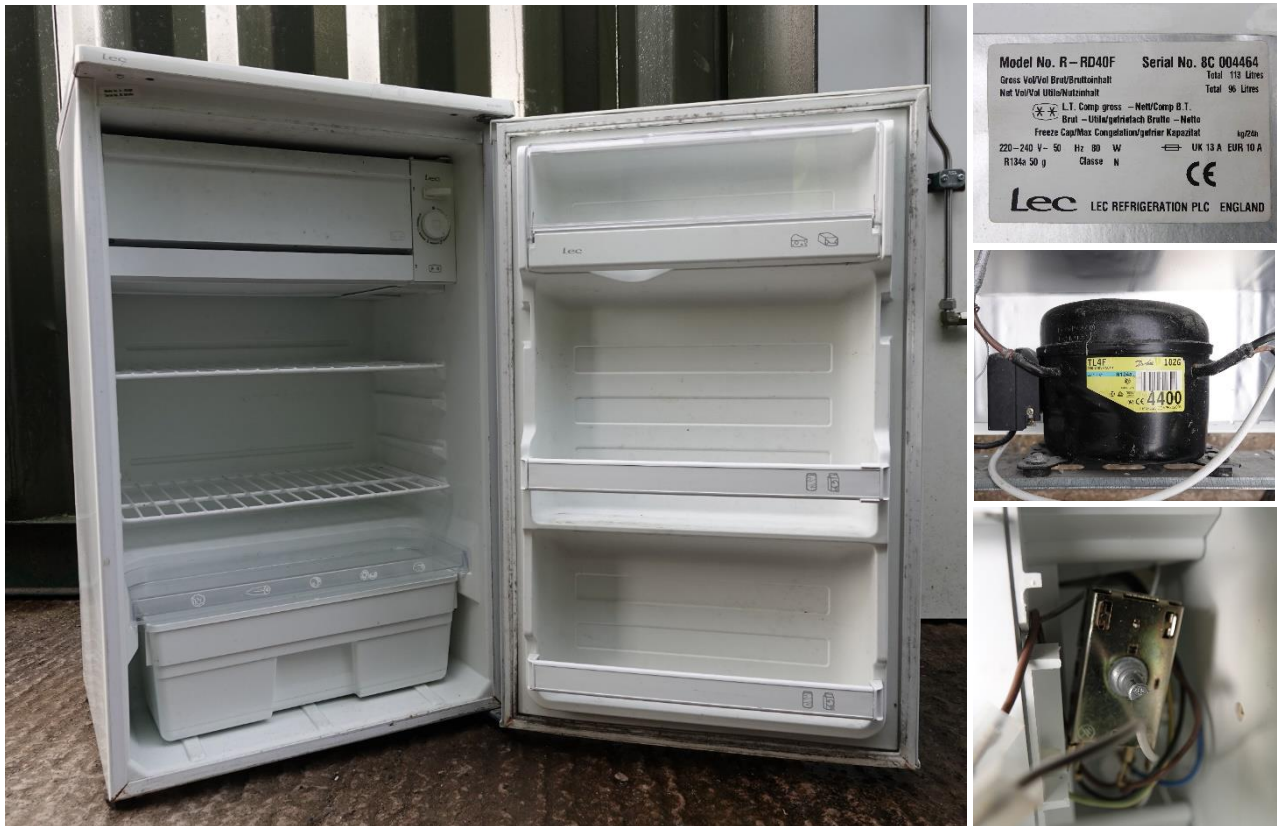
A17. Fridge Unit

Figure A.17 – LEC R-RD40F Fridge unit. Left: as bought condition showing unmodified control unit internally (main body top-right). Upper right: label. Central right: compressor unit. Lower right: switching mechanism.

A LEC R-RD40F fridge unit was procured in a used state. The internal thermostat control unit was bypassed, and the fridge was switched on and off remotely by connecting power. Connecting and disconnecting the power activated/deactivated the compressor unit.

Hydrogen ignition did not occur either with the door closed or the door open. The fridge was not tested with methane.
