Safety Assessment: Experimental Testing – Ignition Potential

Document No.: 636105

Project name: Hy4Heat WP7 Lot 4. GL Industrial Services UK Ltd.
Report title: Ignition Potential Testing with Hydrogen and Methane Region UK
Spadeadam Research and Testing
Customer: Department for Business, Energy & Industrial Strategy, 1 Victoria Street, SW1H 0ET, London, United Kingdom MoD R5, Gilsland, Brampton, Cumbria CA8 7AU United Kingdom
Customer contact: c/o Sophie Brown, Arup Tel: +44(0)16977 47404
Date of issue: 2020-01-20
Project No.: 10158500
Organisation unit: Project Delivery
Report No.: 1, Rev. FINAL 1
Document No.: 636105

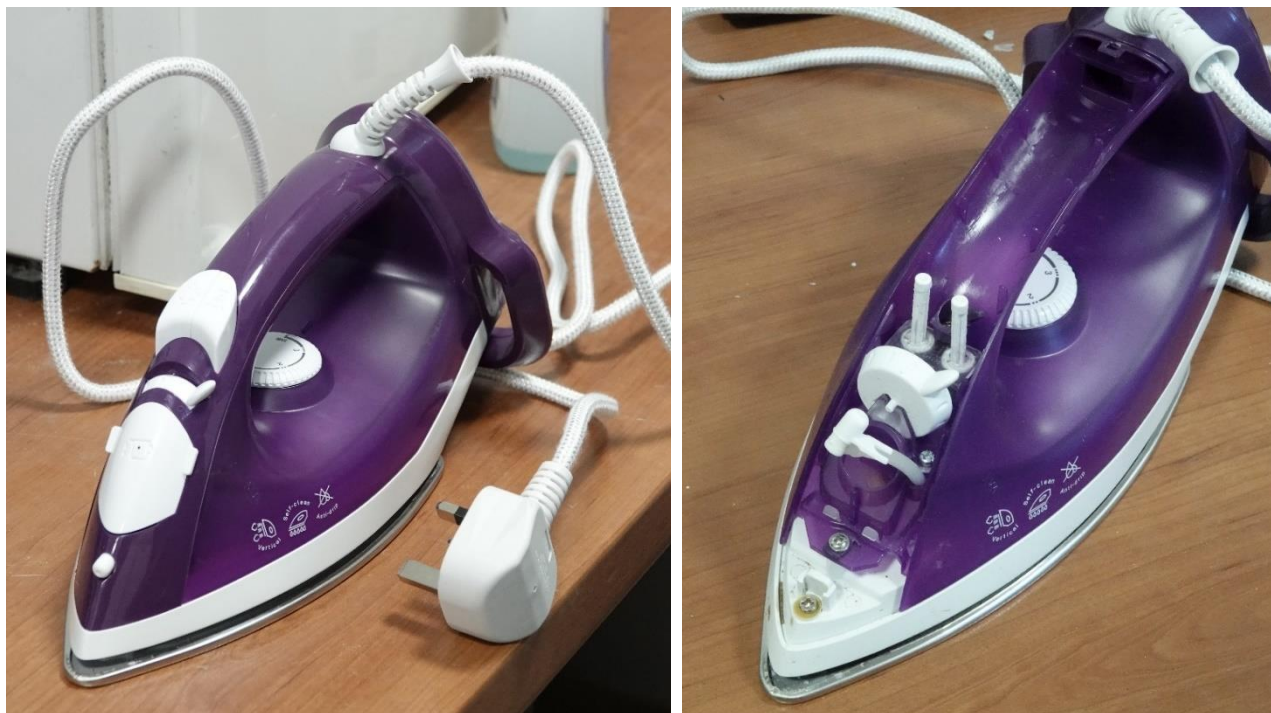
A18. Iron

Figure A.18 – Tesco’s Iron. Left: before testing. Right: after explosion in hydrogen, top part of housing has been blown away

A bottom-of-the-range Tesco iron was procured to represent a common household item.

- It took a long time for some household items to ignite hydrogen. The tumble dryer ignited after 9 minutes operational time on L1 hydrogen, and the iron on L4 hydrogen. In both cases, the key process controlling ignition may not be operational time (or the concentration of hydrogen), but the ability of the hydrogen air mixture to diffuse into the device and reach the ignition source. In the case of the tumble dryer, it was noted that the concentration in the explosion chamber dropped out of acceptable range immediately upon activation, necessitating many hydrogen “top ups” before ignition occurred – indicative of the various voids within the device filling with mixture much slower than the chamber around the device.

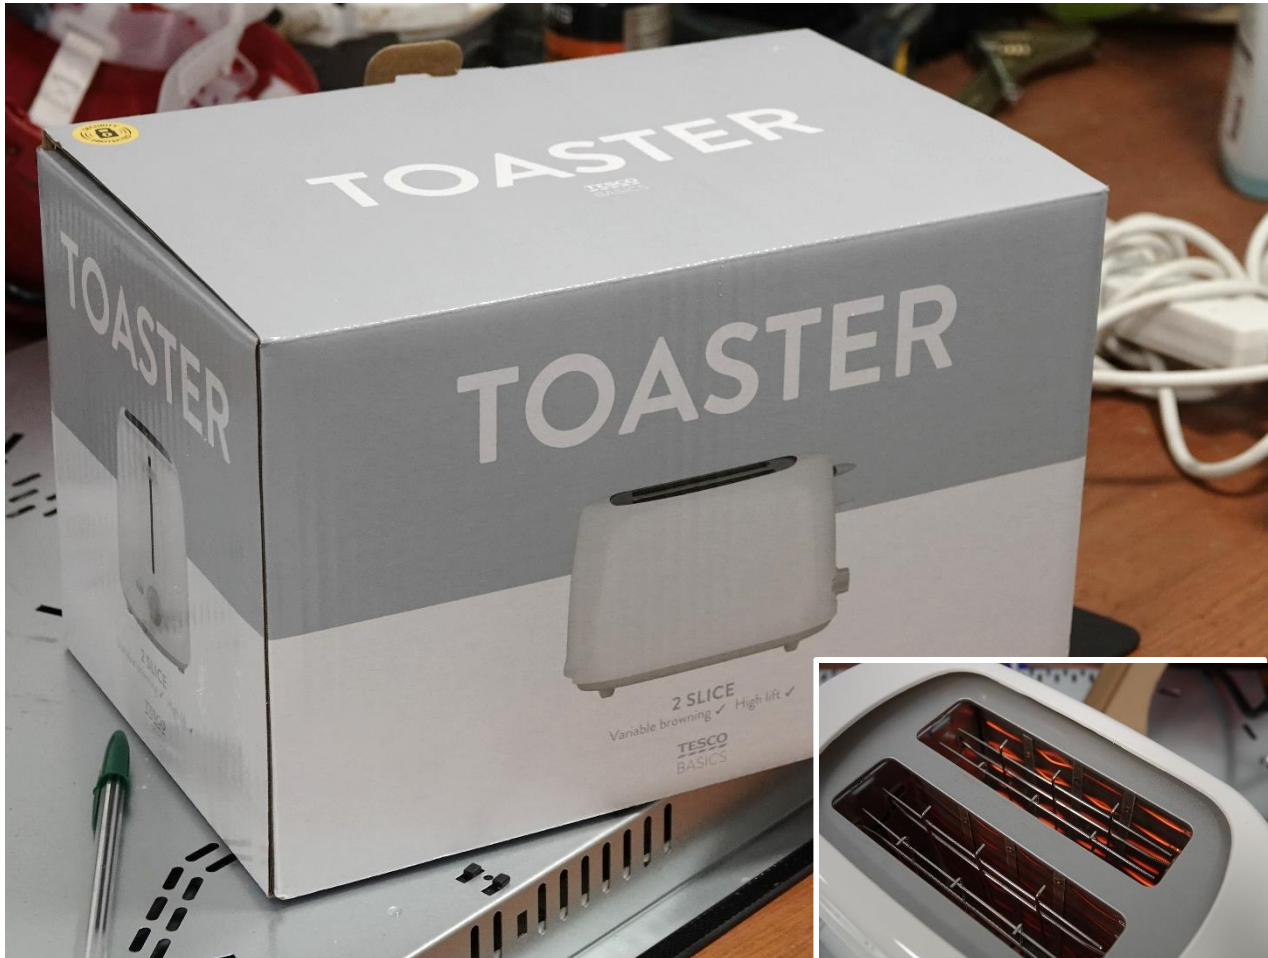
A19. Toaster

Figure A.19 – Tesco’s Toaster. Centre: packaging, Bottom right: closeup of heating elements

A bottom of the range Tesco toaster was used as a representative household item and an ignition of a hot surface ignition source.

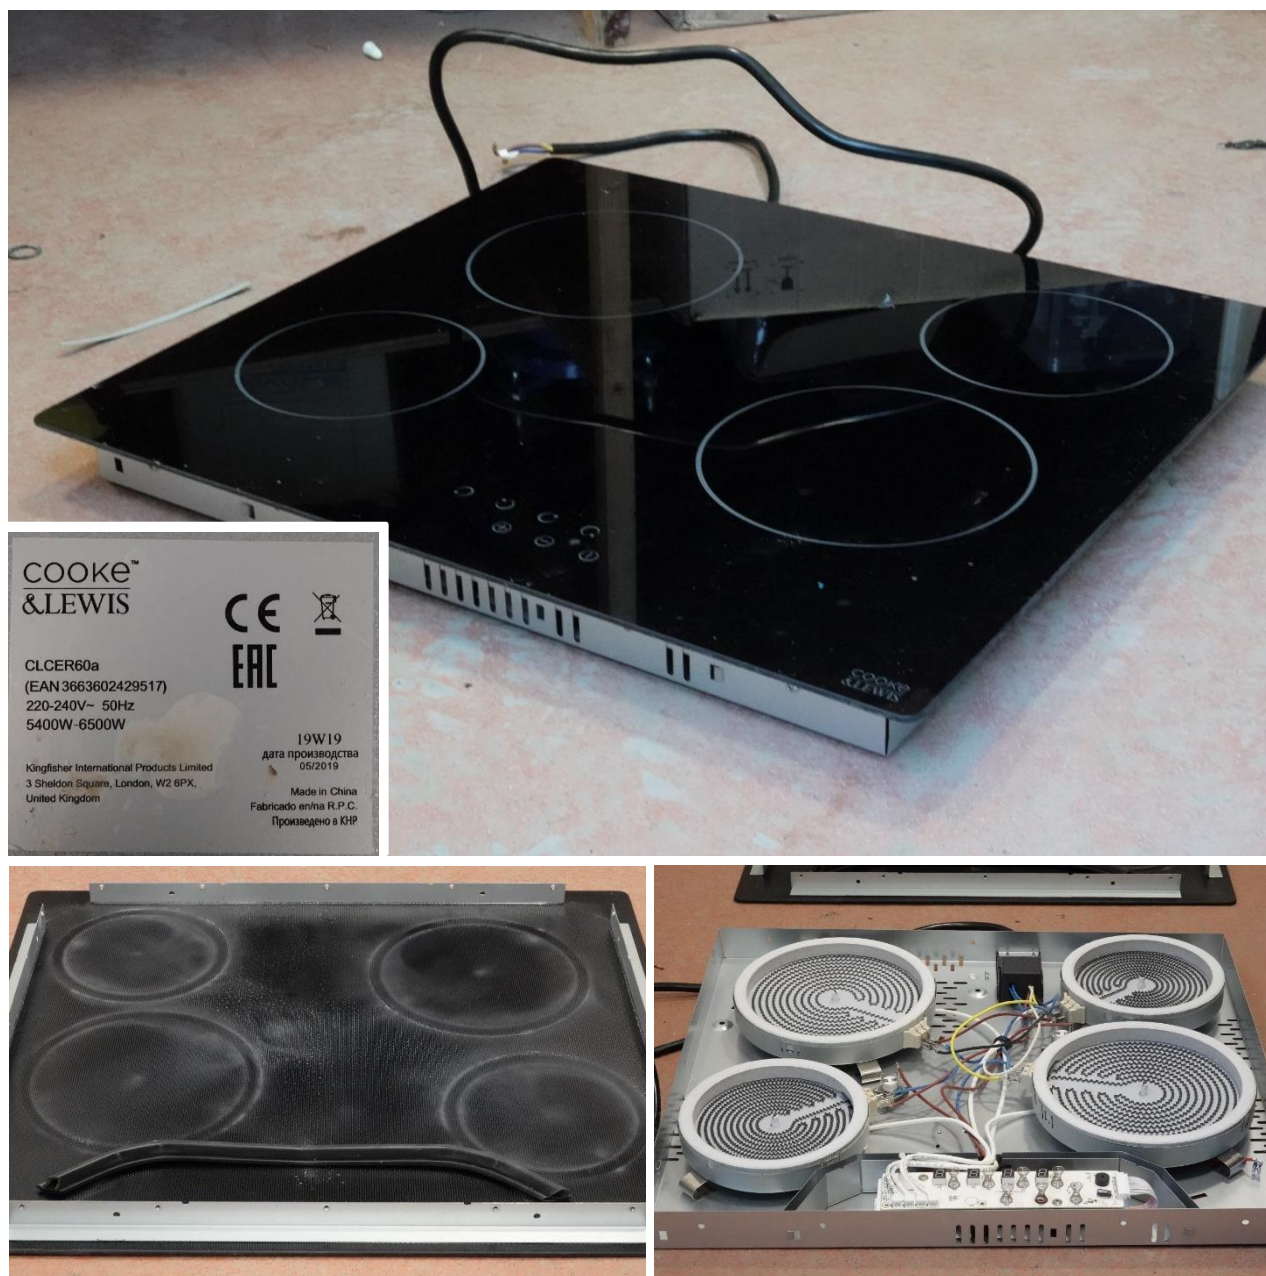
A20. Electric Hob

Figure A.20 – Cooke & Lewis CLCER60A Electric Hob. Upper: as tested condition., Middle right: label., Lower right: exposed heating elements., Lower Left: inside of glass top after testing.

A Cooke and Lewis CLCER60A electric hob was procured as a representative modern electric cooking device. Removing the glass top exposed 4x heating elements surrounded by insulation. It was rewired internally to bypass the manual switches so that all 4 hobs activated simultaneously when the power was switched on remotely. The glass top was replaced for testing.
